Oregon Department of Transportation
**POWELL BOULEVARD
ROAD SAFETY AUDIT**

20th Avenue to 33rd Avenue
September 2014

Powell Boulevard Road Safety Audit (RSA)

20th Avenue to 33rd Avenue
Mile Point (M.P.) 1.76 to 2.49

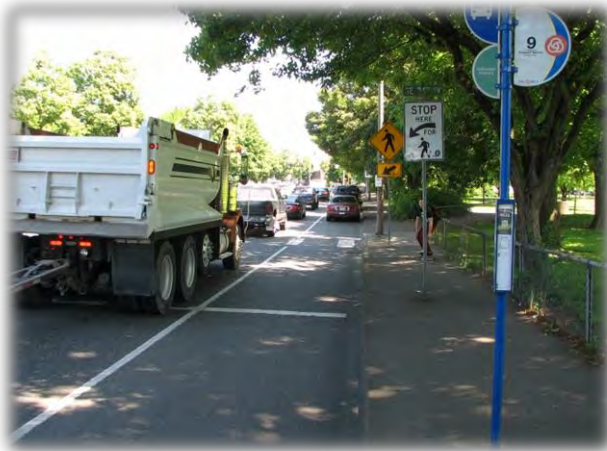
- Location of pedestrian crossings
 - Several pedestrian crossings were located downstream from transit stops, as shown in Exhibit 4. This placement results in a stopped bus at the transit stop sometimes blocking a driver’s view of a crossing pedestrian.
- Sign visibility
 - The visibility and reflectivity of signs, including pedestrian crossing signs, was restricted by street trees, as shown in Exhibit 5 and Exhibit 6. The tree canopies extend below the signs further restricting visibility of the signs. The limited visibility of signs may contribute to subsequent approaching drivers failing to see regulatory and/or warning signs and yield to the pedestrian.

Exhibit 4 Transit Stop Located Before Pedestrian Crossing

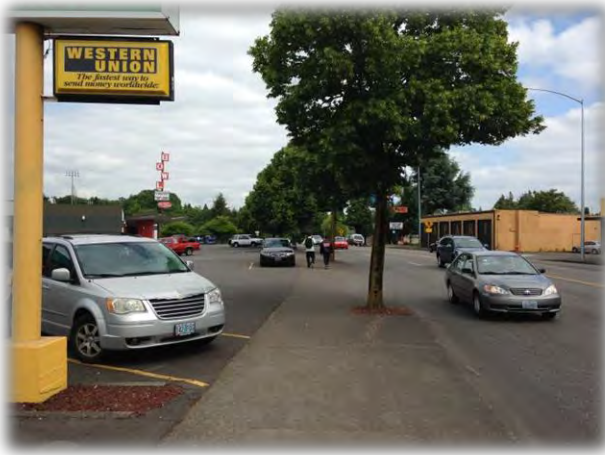
- Sight lines
 - Sight lines between drivers and pedestrians are often restricted throughout the corridor by buildings, trees, and roadway curvature, as shown in Exhibit 7 and Exhibit 8. The trees have wide trunks and undergrowth reducing visibility from the roadway to the sidewalk and crossing locations.
- Crossings at traffic signals
 - Some of the pedestrian involved or injured crashes occurred at traffic signals with marked crossings. The signals at 21st Avenue and 33rd Avenue have unprotected left-turn phases on all movements. The signal at 26th Avenue has unprotected side street left-turn phases.

Exhibit 8 Limited Sight Distance Due to Trees on Horizontal Curve

- Trim trees to provide clear height to make visible signs to drivers. This includes trimming the tree canopy as well as undergrowth at the base of the tree. Consider a minimum tree trimming height of 12 feet (typical height of sign assembly) to allow for visibility of all signs.
- Provide signing and striping improvements, which may include signs in Exhibit 12, to increase awareness of pedestrian crossings.
- Provide a leading pedestrian phase at signalized intersections to allow pedestrians to enter the intersection (increasing their visibility) before vehicles enter the intersection.
- Expand pedestrian landing areas on the corners of Powell Boulevard/26th Avenue to discourage pedestrians (e.g., students at Cleveland High School) from standing in the roadway.

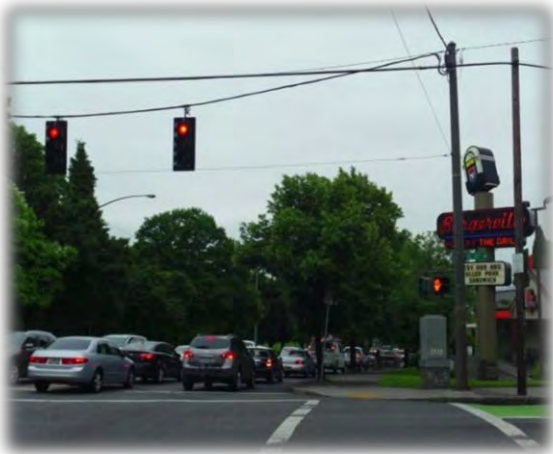
As shown in Exhibit 2, 71 percent of reported crashes were rear-end crashes. While some of these crashes were associated with pedestrians, many were also associated with congestion throughout the corridor. Queues from traffic signals were observed to back-up to and sometimes beyond the next upstream signal during observed peak hours, as shown in Exhibit 13 and Exhibit 14. Visibility of signage (including information about the approaching intersection) was limited due to vegetation and reflectivity as previously discussed.

Exhibit 13 Queues Extend Signal to Signal

- Complete tree trimming to increase visibility of signs and approaching signals.
- Consider supplemental signal heads at near left side corner, as illustrated in Exhibit 15.
- Review sign placement and visibility. For example, consider using the back side of cantilever for the “Next Signal” sign for the eastbound approach to 26th Avenue as illustrated in Exhibit 16.

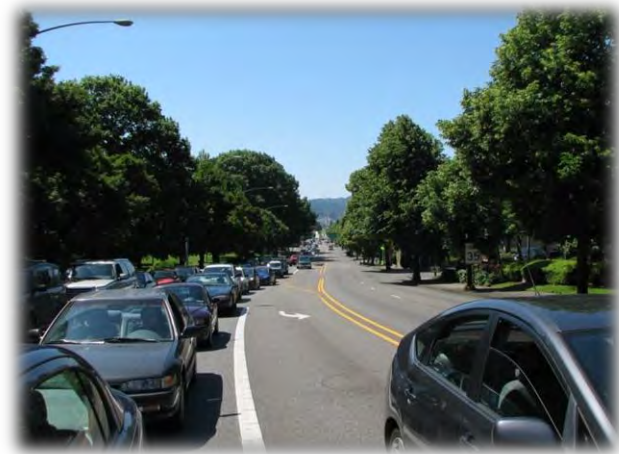
The signals cycle length also appeared to influence driver behavior along the corridor. The cycle observed at the signal at Powell Boulevard/26th Avenue during the afternoon peak hour appeared to allow approximately 30 seconds of green time, per cycle, to the east-west movements on Powell Boulevard. This congestion and observed cycle length appeared to lead to impatience among drivers; the RSA team observed drivers running the red lights at traffic signals to make it through the signal during the cycle. This impatience and cycle length may also contribute to the rear-end crashes along the corridor as drivers start to proceed forward and then have to stop sooner than they expect.

Exhibit 14 Queues at the Powell Boulevard/26th Avenue Signal

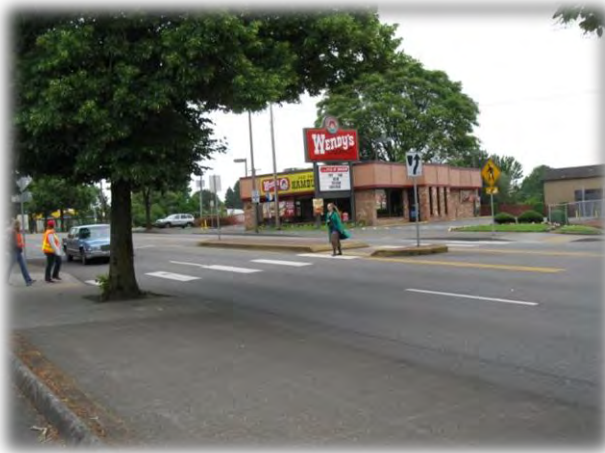
The crash history revealed 13 of the 351 crashes along the corridor occurred at a driveway and/or alley. However, the distraction of drivers caused by many access points in conjunction with pedestrian crossings, pedestrians on the sidewalk, and bicycles on the sidewalk or roadway, as illustrated in Exhibit 21, may contribute to the rear-end crashes in the vicinity of the driveways.

Exhibit 19 Example of Driveways Located Adjacent to Pedestrian Crossings

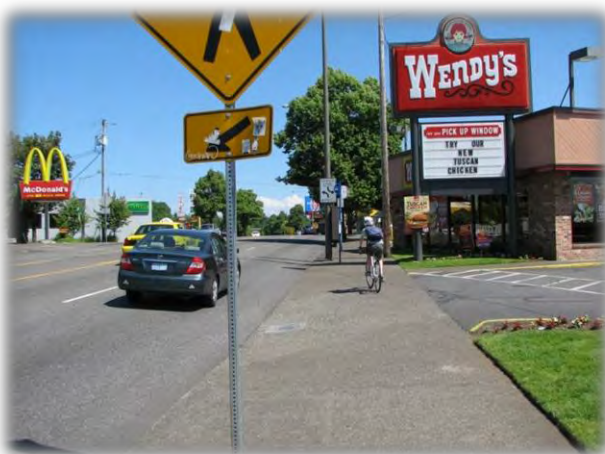
Exhibit 21 Example of Potential Bicycle/Pedestrian/Vehicle Conflict at Commercial Driveway

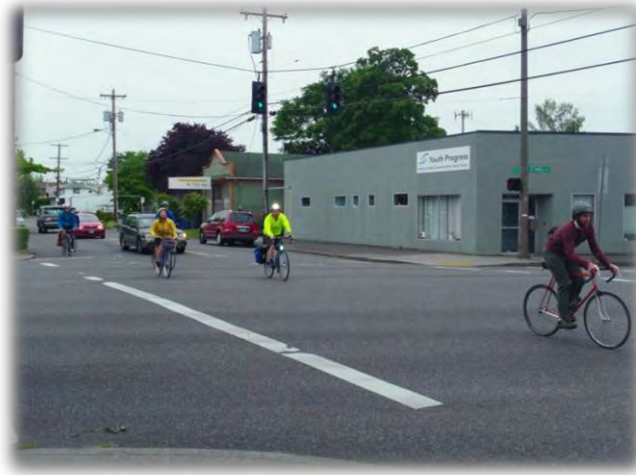
an example of bicyclists crossing Powell Boulevard at 21st Avenue. Location-specific treatments will be discussed in the next section of the report; this Issue summarizes general treatments that can be considered for bike crossings of Powell Boulevard within the study area.

Exhibit 22 Example of Bicyclists Crossing the Intersection of Powell Boulevard/21st Avenue

- Consider installing sharrows on lower volume, lower speed streets to inform drivers to share the lane with bicyclists and/or inform cyclists of a potential bike route. Exhibit 24 illustrates the lane marking for sharrows.

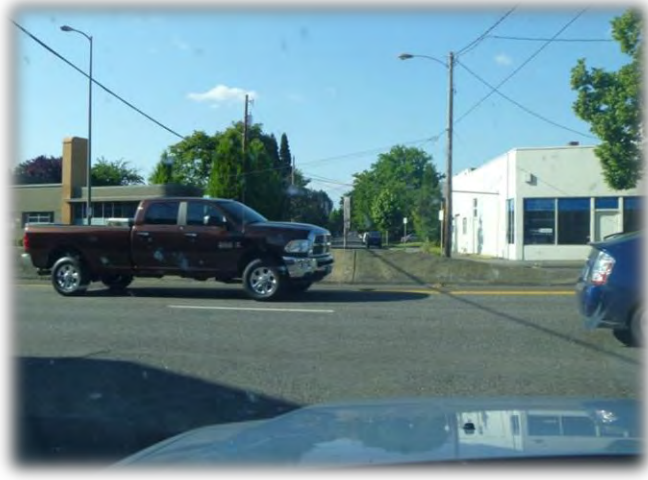
Exhibit 28 Lack of One Way Signage Directly in Front of Approach

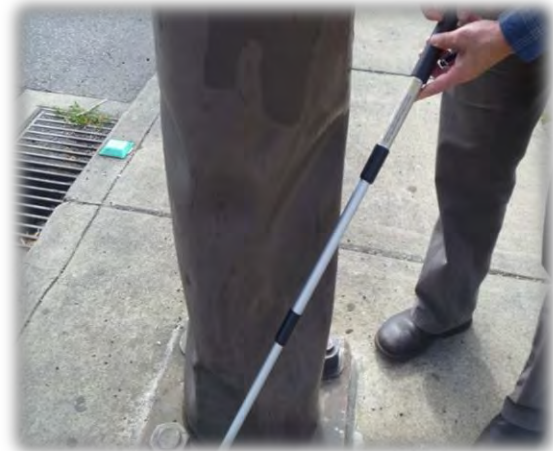
Exhibit 30 Example of Dented Pole

- Provide protected or protected/permissive left-turn phasing for all approaches. Signal phasing adjustments should include a capacity implication analysis during project planning stages.
- Consider restricting rightturn onred for the northbound approach using signage, as illustrated in Exhibit 32.
- Install supplemental signal heads to increase awareness of approaching intersection as discussed under the “Congestion and Associated Traffic Signal Queuing” section.
- Rebuild signal with mast arm street name signs to increase visibility. Consider placing signal poles to accommodate truck movements in the new design.
- Consider a queue detection and warning system to detect queues on Powell Boulevard associated with 21st Avenue signal.

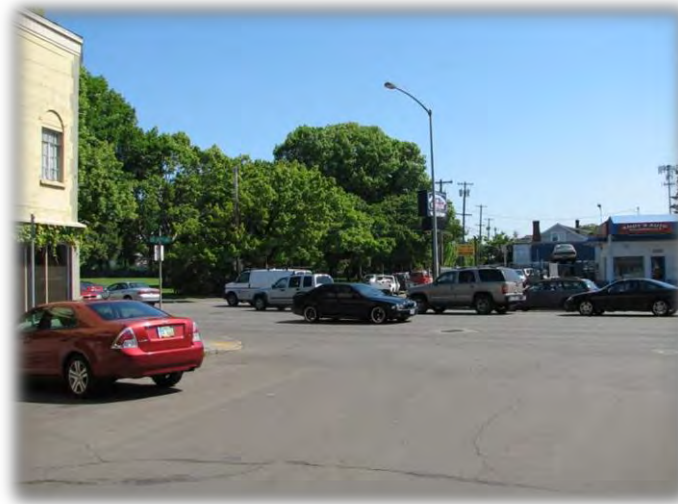
The Powell Boulevard/22nd Avenue intersection is an offset, unsignalized intersection. The RSA team observed angle parking on the east side of 22nd Avenue (north of Powell Boulevard) being used incorrectly, as illustrated in Exhibit 33. Vehicles park in a southbound direction on the east side of the street rather than in a northbound direction, with the flow of traffic. Although this is unconventional, there appears no issue related to the existing parking configuration. The northbound stop bar is placed back from the assumed crosswalk and appears to restrict sight distance.

Exhibit 33 Example of Incorrectly-Used Angle Parking on 21st Avenue, North of Powell Boulevard

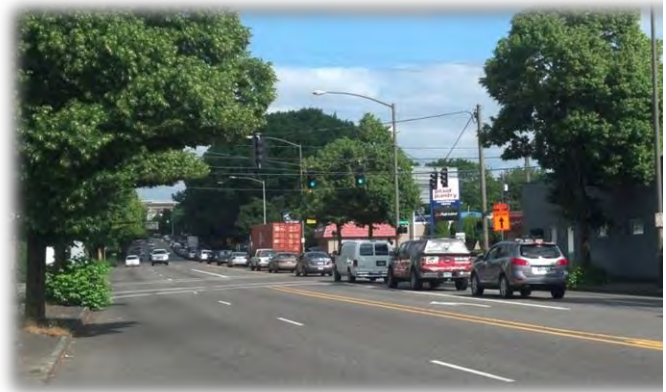
Exhibit 35 Queues blocking intersections

- Consider adding an RRFB and pedestrian scale lighting in advance of the crosswalk, as shown in Exhibit 36.
- Consider removing select tree(s) to increase visibility of crossing, signage, and pedestrians. Consider eliminating or relocating eastbound TriMet stop downstream of the crosswalk. The spacing between this stop and the next stop at 26th Avenue should be considered in the decision.

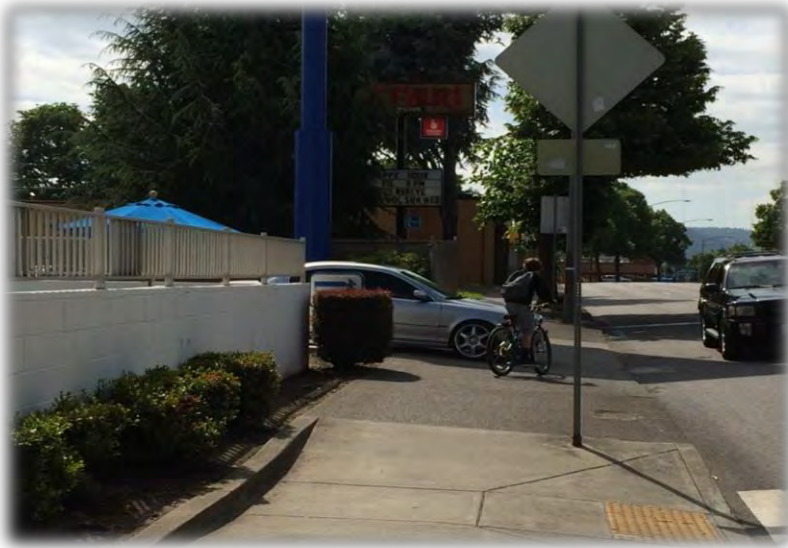
The southbound intersection approach has restricted sight distance to the east due to a lack of maintenance of vegetation on the school property corner and the approach grade, as shown in Exhibit 44. The northbound approach (Motel 6 driveway) has restricted sight distance caused by a fence in the southwest corner of the intersection, as shown in Exhibit 45.

Exhibit 45 Motel 6 Driveway Conflicts with Bicyclists

- Consider removing vegetation in northeast corner of the intersection to improve sight distance.
- Consider making the southbound approach right-only (due to new pedestrian refuge median as well as restricted sight distance).

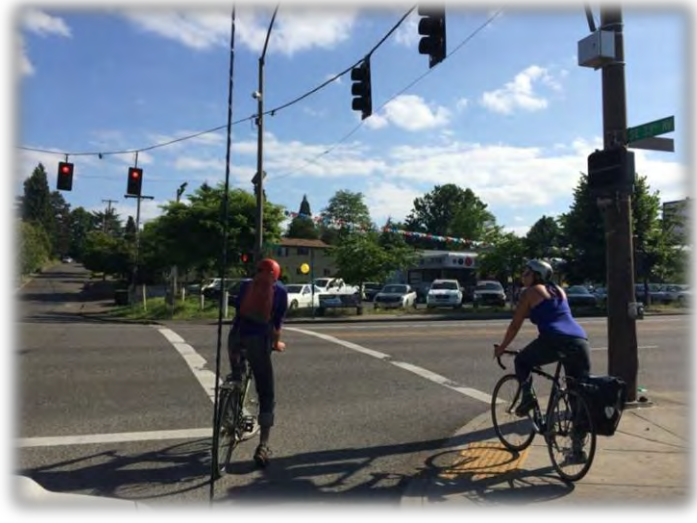
The signal has permitted left-turn phases for all approaches. The RSA team observed it was difficult to make left-turns from Powell Boulevard with the permitted phases. In addition, the cycle length was observed to be relatively long. Pedestrians were observed to cross during the Don't Walk time. Bicyclists were observed using the pedestrian push button after waiting for the signal to change, as illustrated in Exhibit 48. Although there was a bicycle detection symbol in the pavement on the side street approaches, it was unclear if the detector is functioning.

Exhibit 48 Bicyclists Using Pedestrian Push Buttons

- Review signal timing and cycle lengths:
 - Consider pedestrian and bicyclist wait times;
 - Consider protected/permissive left-turn phasing from the mainline;
 - Consider providing an indication of bicycle detection to discourage impatience;
 - Consider running the signal at 33rd Avenue with half cycle compared to other signals within the corridor due to pedestrian/bicyclists frustration; and,
 - Consider installing a new signal with mast arms. Pole placement will be a focus to improve awareness of the approaching intersection as well as ensure adequate turning radii.

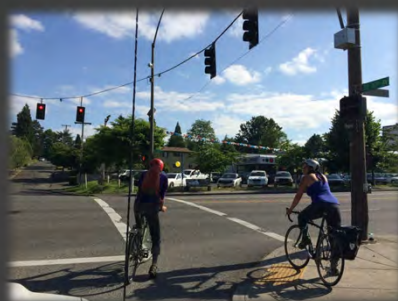
Bicyclists using pedestrian push button

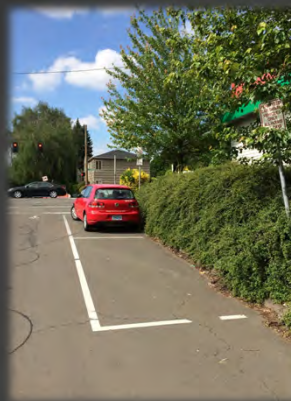
ZipCar located at intersection
