CITY OF
PORTLAND
BUREAU OF
TRANSPORTATION

RE: Progress Report: Request to Experiment "9-105(E)—Colored Bike Lanes and Bike Boxes—Portland, OR"

Subject: Kathryn Rickson Death Investigation

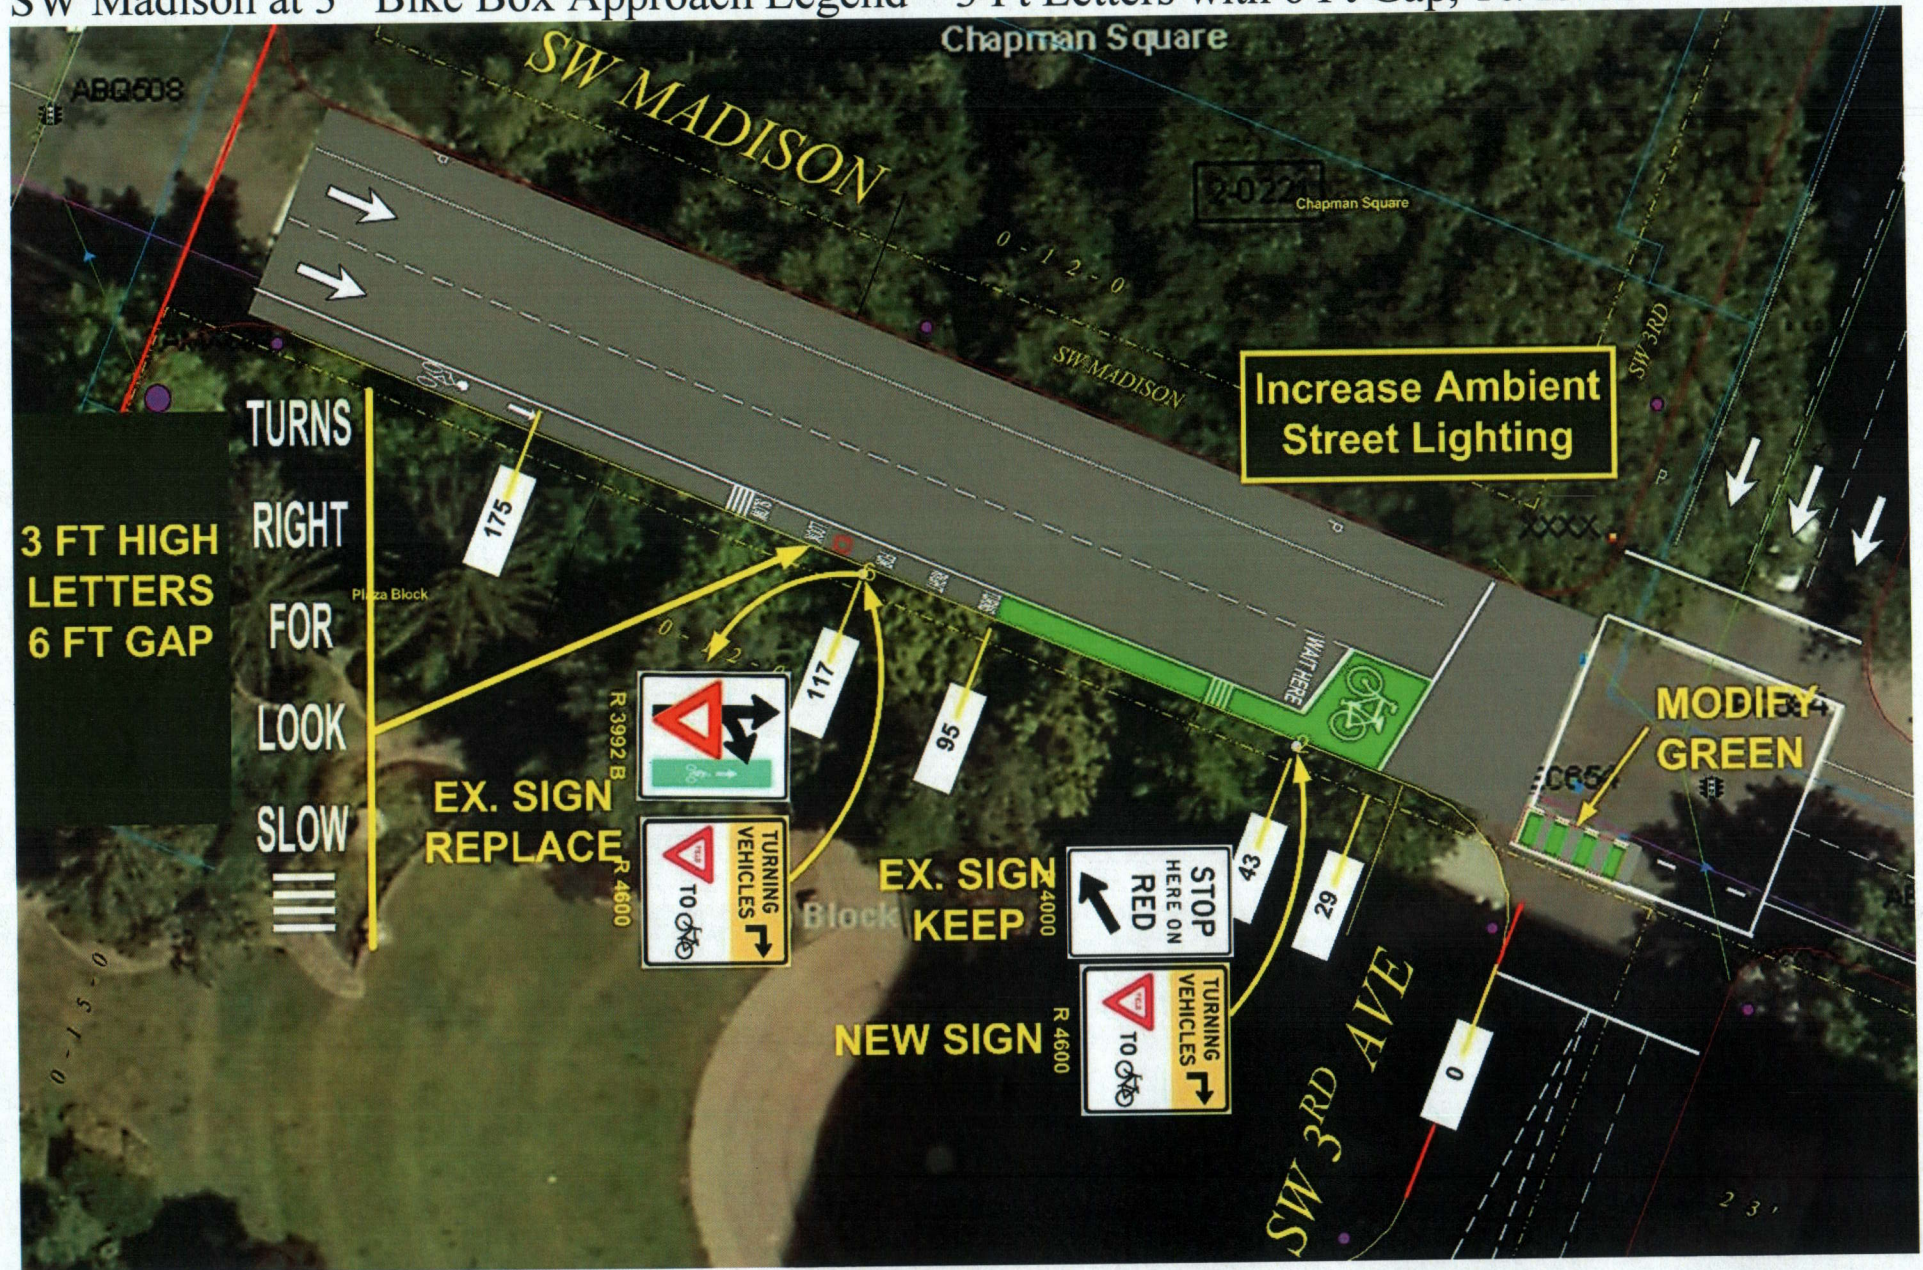
SW Madison at 3rd Bike Box Approach Legend – 3 Ft Letters with 6 Ft Gap, 10/15/12

Despite these factors we believe that the crash data trend suggests that right-hook crashes are increasing at some of the treatment locations installed in the first phase. See attached crash data summary. During the four years prior to treatment there were a total of 16 bicycle involved right-hook crashes at the 11 intersection approaches that received treatment. During the four years after treatment there were a total of 32 right-hook crashes. A total of 26 of the 32 right-hook crashes (81%) occurred at four locations. A total of 9 of 16 (56%) right-hook crashes occurred at these four locations before the treatment. By comparison, at the remaining seven treatments locations there were 7 right-hook crashes before and 6 after. The attached crash data table provides a summary of the four year crash history before and after the treatment.

The four locations that were responsible for the increase in crashes are:

- SW Madison at SW 3rd Ave.
- SE Hawthorne at SE 7th Ave.
- SE Hawthorne at SE 11th Ave.
- NW Everett Street at NW 16th Ave.

From this analysis we concluded that a high proportion (88%) of the crashes occurred during the 'stale' green condition. Furthermore, we made field observations of the roadway conditions, driver behavior, and cyclists operating behavior and found:

- All three locations have downhill grades on the treatment approach.
- The 85% speed for cyclists observed overtaking right-turning vehicles was approximately 18 mph, which we find to be fast speed for the condition.
- A high percentage of cyclists were overtaking right-turning vehicles during the peak-hour observation periods.
- A very high percentage of vehicles (98%) yield to cyclists over-taking on their right.

We expect to have final designs ready for implementation at these four locations during the 2013 construction season. In the interim we plan to implement additional warning messages for cyclists that are intended to increase the awareness of cyclists of the risk of right-hook conflicts. These modifications will include some or all of the following treatments as shown in the attached graphic for SW Madison Ave at SW 3rd:

- Update 'Right Turn Yield to Bicycles' sign to most current version approved for Experiment 9-105(E) and add a second sign for emphasis.
- Add supplemental pavement marking warning messages in the bike lane approaching the intersection. SLOW, and LOOK FOR RIGHT TURNS.
- Modify the green pavement marking within the bike lane extension to create a broken pattern that matches the cycle of the dotted bike lane lines. We believe that the broken green pattern might more clearly communicate that this is a conflict area to people riding bicycles.
