Effects of Bicycle Boxes on Bicyclist and Motorist Behavior at Intersections

The City of Austin Bicycle Team
Jeff Loskorn, Alison Mills, John Brady, Jen Duthie, Randy Machemehl
Center for Transportation Research
The University of Texas at Austin
Phone: (512) 471-4541
Fax: (512) 475-8744
Email: jloskorn@gmail.com

Report Submitted August 2, 2010

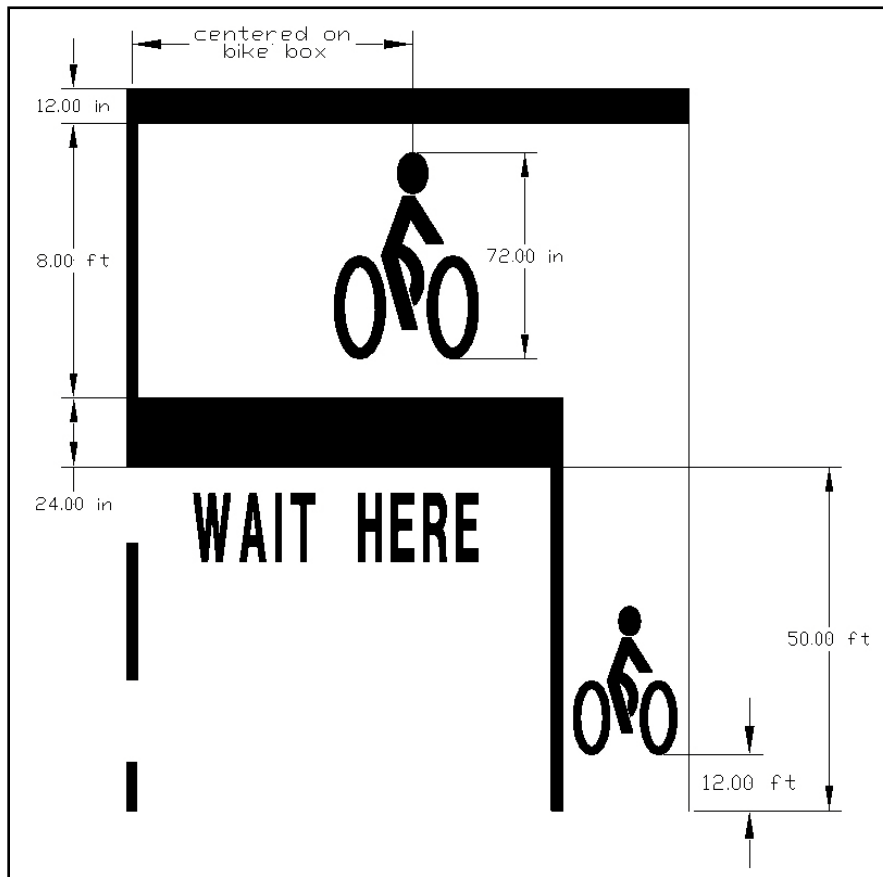
The dimensions of the bicycle box are shown in Figure 1. The bicycle box consists of a 24-inch advanced stop bar and an eight foot deep box (based on bicycle box measurements in Eugene, Oregon) containing a bicycle symbol. Before bicycle box installation, both intersections studied in Austin had the motorist stop line set back 4.5 feet from the crosswalk (measurement taken between the painted lines). After bicycle box installation, this distance increased to between 8 and 8.5 feet. "Wait Here" is painted on the roadway to instruct motorists to wait at the stop bar. The cost of the "Wait Here" symbol is \$267.66. Cold thermoplastic material was purchased at \$4.46 per square foot and was used for the box and approaching bicycle lane. As recommended by the National Committee on Uniform Traffic Control Devices (NCUTCD), a chartreuse (or strong yellow green) color was used. The material is embedded with corundum for traction. In addition, bicycle symbols were installed at the beginning of the green thermoplastic and in the middle of the bicycle box. Each symbol costs \$98.21. Given these numbers, an eight foot deep bicycle box in a ten foot wide lane costs \$1596.92 in materials.

Figure 1. Dimensions of bicycle box

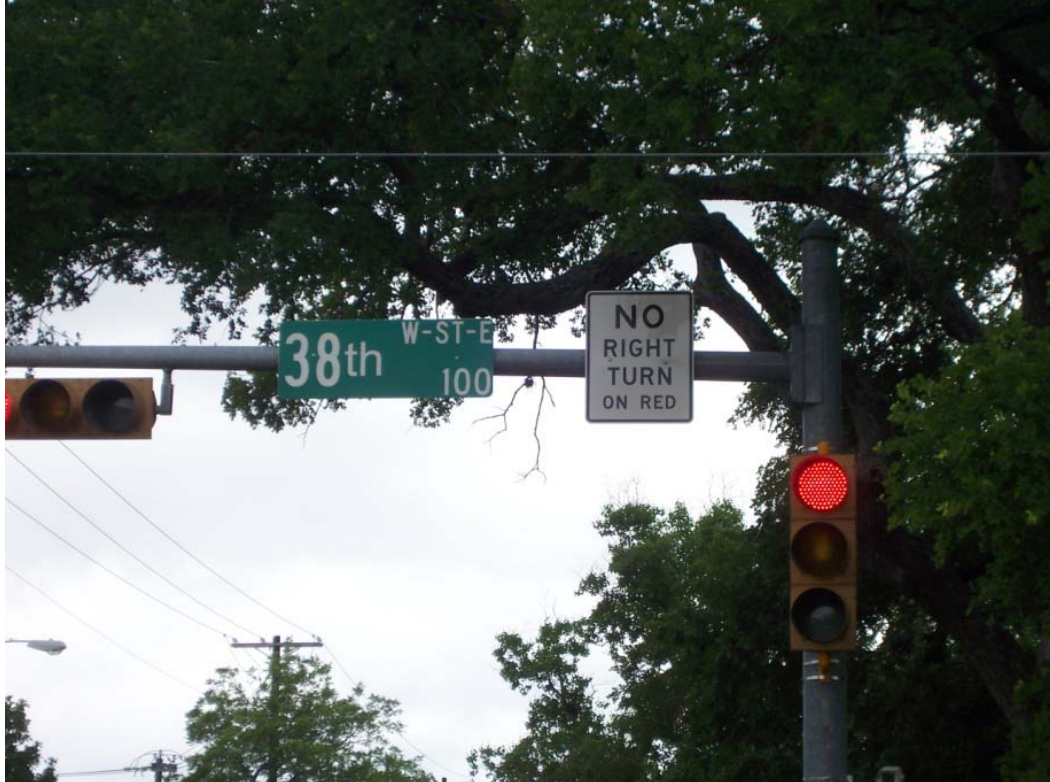
Additionally, "No Right Turn on Red" signs were installed when the color was added to the bicycle boxes in attempts to prevent motorists from encroaching on the bicycle box and to further prevent right-hooks, where a right turning motorist sideswipes a bicyclist traveling straight through the intersection. The "No Right Turn on Red" sign installed at Speedway and at 38th Street is shown in Figure 2.

Figure 2. The "No Right Turn On Red" sign installed at 38th Street

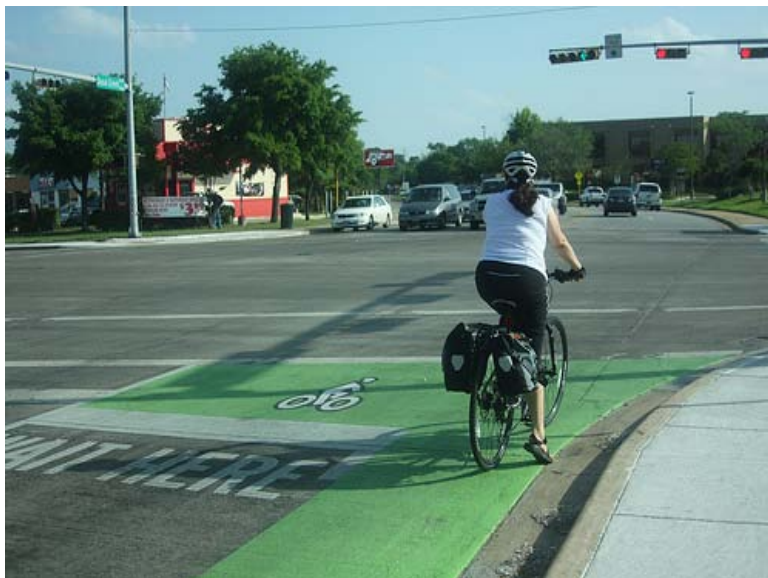
A bicycle box was installed on Shoal Creek Boulevard heading south to alert motorists of the presence of bicycles at the intersection and give bicyclists the right-of-way as they transition from the bicycle lane to the stretch of roadway where the bicycle lane ends briefly. Figure 3 shows the colored bicycle box and Figure 4 shows a map of the intersection and the location of the bicycle box.

Figure 3. The bicycle box on Shoal Creek Boulevard at Anderson Lane

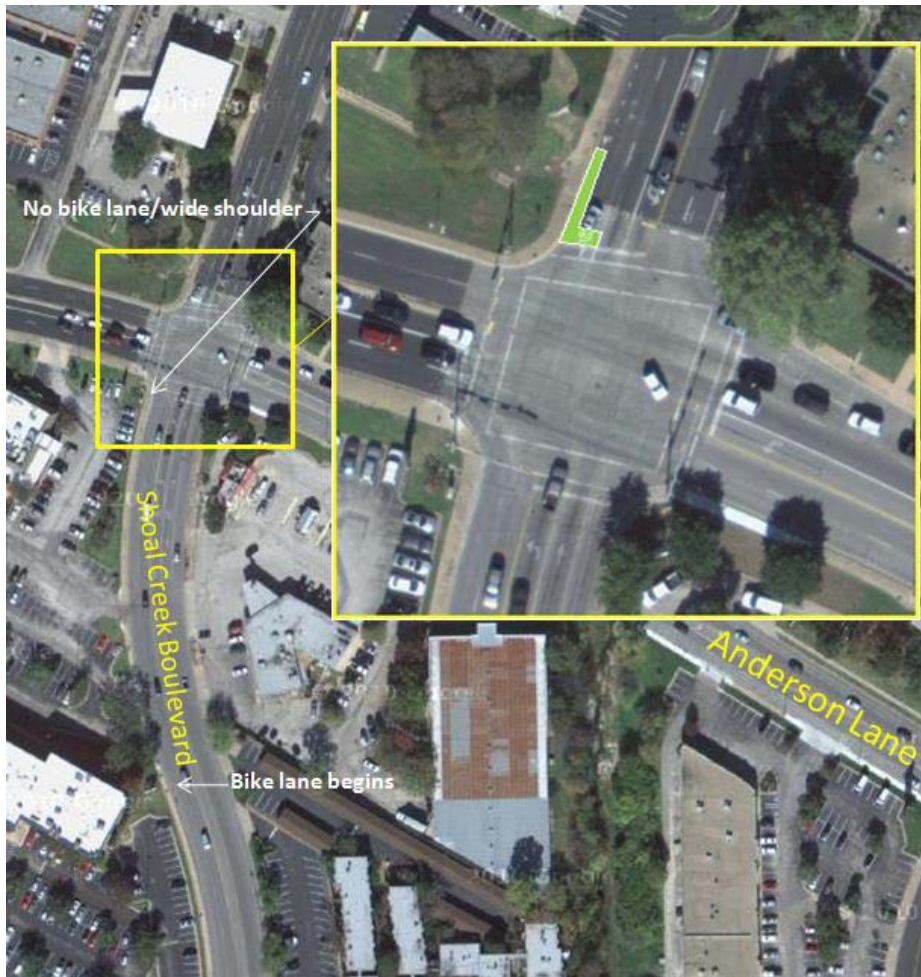
Figure 4. The intersection of Shoal Creek Boulevard and Anderson Lane

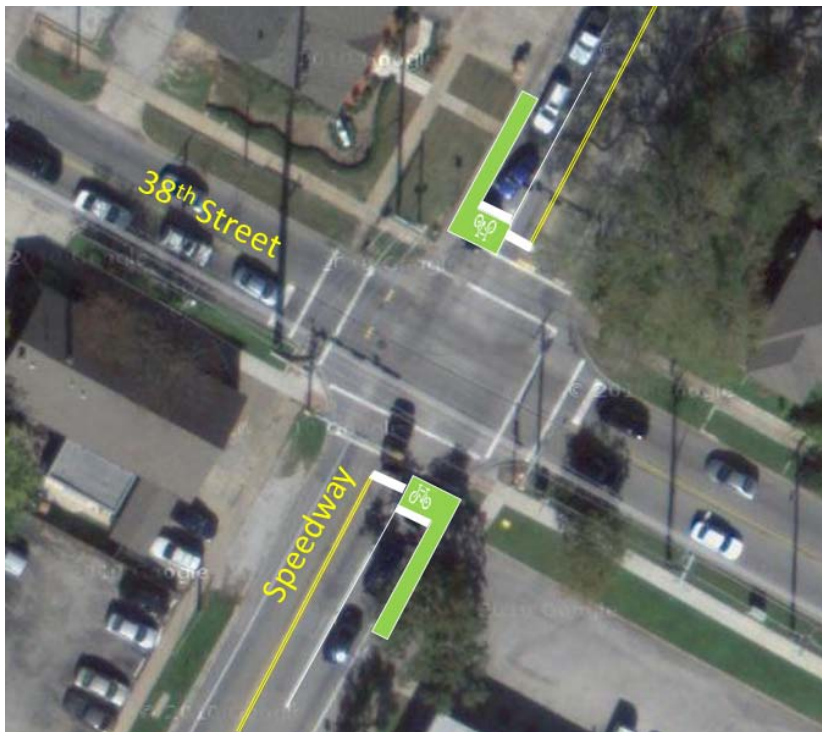
Speedway is primarily a one lane street that runs north-south through The University of Texas and connects the Hyde Park area with campus. Bicycle lanes in both directions make this facility attractive to many students living north of campus. Bicycle boxes were installed on both sides of Speedway at 38th Street to alert motorists to the presence of bicycles at the intersection and give them the right-of-way. The researchers hypothesized that bicyclists would be less likely to use the bicycle box at this location because the bicycle lane continues on the opposite side of the intersection. Data was collected on northbound Speedway during afternoon hours as students departed the university. A map of the intersection and the location of the bicycle boxes is shown in Figure 5. The posted speed limit is 25 mph and the observed hourly traffic volumes ranged from 150 vph to 250 vph in the afternoon.

Figure 5. The intersection of Speedway and 38th Street

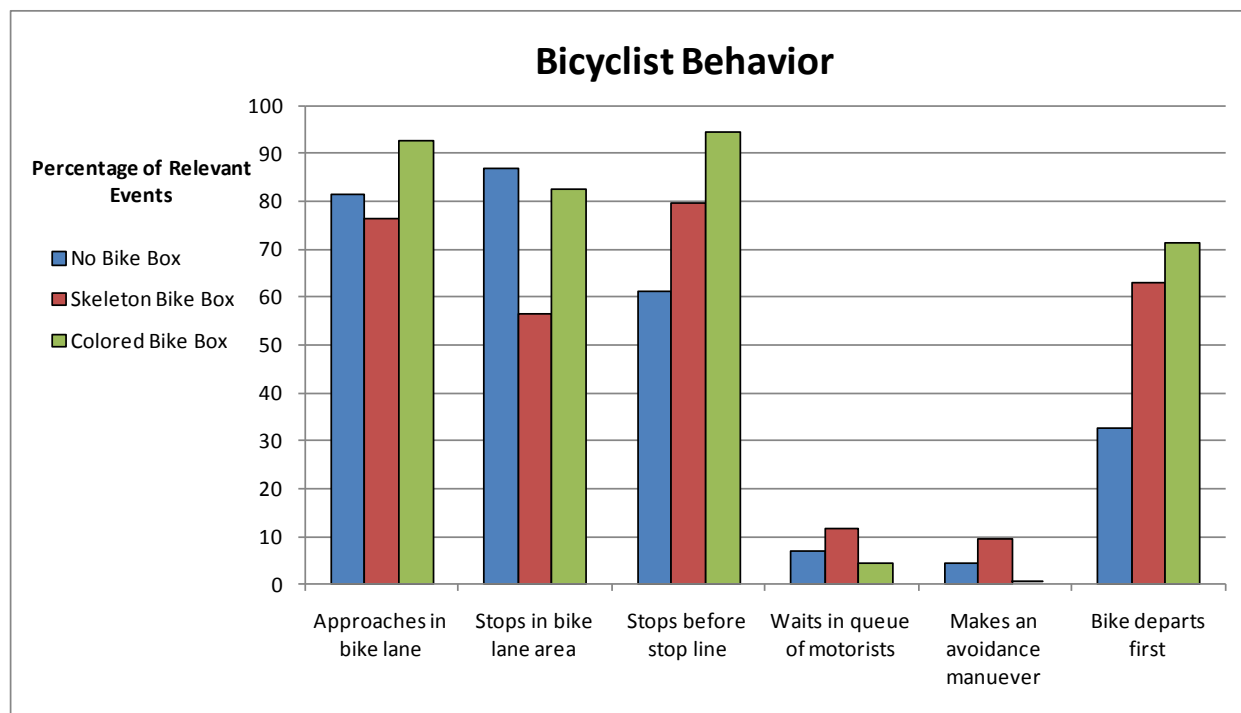
Figure 6 shows the changes in bicyclist behavior before the bicycle box existed, after the skeleton bicycle box was installed, and after the chartreuse color was added. The percentage of bicyclists who approached the intersection in the bicycle lane remained about the same after the bicycle box skeleton was installed. However, after the color was added to the bicycle box the percentage of bicyclists who approached the intersection using the bicycle lane significantly increased from 77% to 93% ($p = 0.005$). This may suggest that the colored lane leading to the bicycle box encourages bicyclists to approach in the bicycle lane rather than the full lane.

The proportion of bicyclists that stopped before the stop line increased significantly after each phase of bicycle box installation as shown in Figure 6. This suggests that the bicycle box skeleton and added color were successful in encouraging bicyclists to stay behind the stop line within the bike box area. The percentage of bicyclists that departed first at the intersection also steadily increased after each phase of installation. This increase proved to be more significant from the before condition to the skeleton bicycle box condition than from the skeleton bicycle box condition to the implementation of color ($p < 0.001$ versus $p = 0.267$). This could indicate that the presence of the bicycle box causes motorists to be more aware of the presence of the bicyclist. However, the higher percentage of bicyclists departing first may simply be attributed to the fact that the motorist stop bar is advanced four feet further from the intersection when the bicycle box is in place than under the original conditions. So even though bicyclists are stopping further back from the intersection (because they are encroaching on the crosswalk less frequently), right-turning and through-movement motorists are stopping even further back (behind the advanced stop line) and are often allowing the bicyclists to pull into the intersection first.

Figure 6. Bicyclist behavior on Shoal Creek Boulevard and Anderson Lane

The percentage of bicyclists that waited in the queue did not change significantly across the three bicycle box phases ($p = 0.286$ and $p = 0.103$ for the two phase changes). Researchers discovered that bicyclists waited in the queue more often when it is dark so only daytime events were considered for the "Waits in the queue of motorists" variable. Incidences where a bicyclist made an avoidance maneuver increased after the bicycle box skeleton was installed ($p = 0.132$). However, no instances of avoidance occurred after the color was added indicating that

color may make bicyclists more comfortable with stopping at the intersection rather than on a sidewalk. While only data observed during daylight hours was incorporated into the analysis, it is interesting to note that bicyclists riding at night were observed to stop in the motor vehicle lane significantly more frequently perhaps to increase their visibility to oncoming motorists.

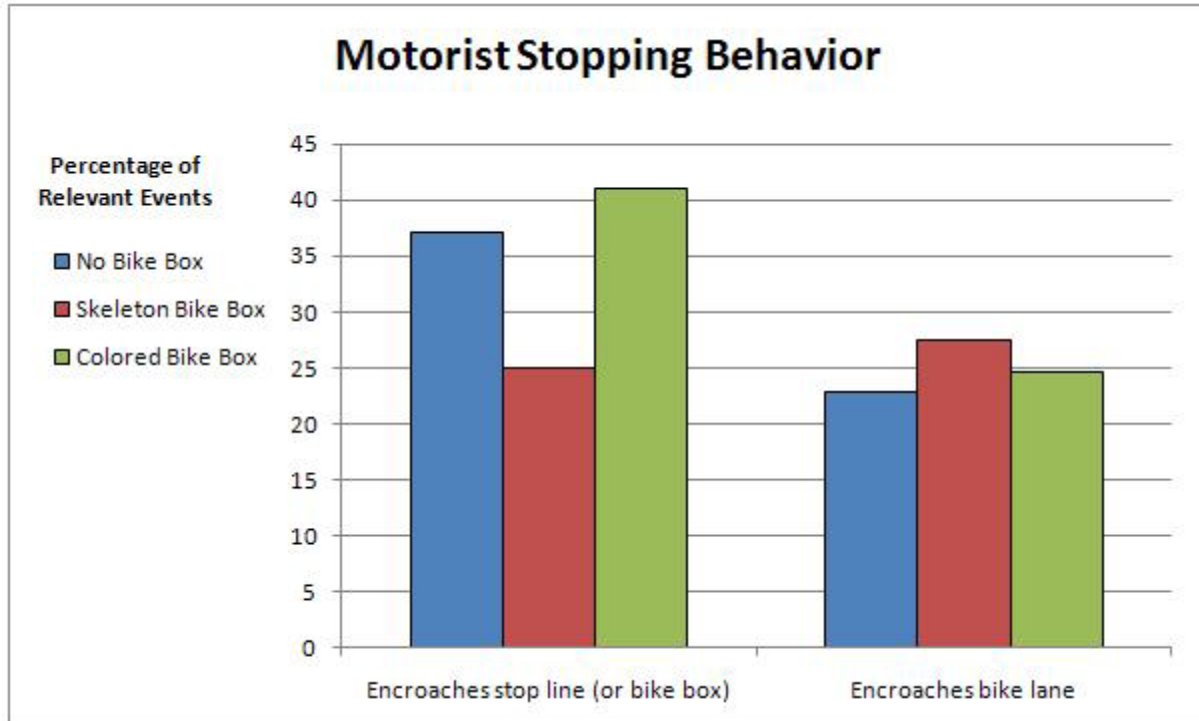
Motorist stopping behavior is shown in Figure 7. The percentage of motorists that encroached on the stop line significantly decreased after the bicycle box skeleton was installed ($p = 0.099$). After the color was added the percentage of motorists encroaching on the stop line increased compared to the Phase 1 condition. One hypothesis for why this occurred is that motorists were inclined to initially comply with the new site design, but as it became clear that the percent of time when a bicyclist was in the box was low, they began to ignore the advanced stop line. Incidences of encroachment on the bicycle lane remained mostly constant over the different phases of implementation.

Figure 7. Motorist stopping position when a bicyclist is present at Shoal Creek Boulevard and Anderson Lane

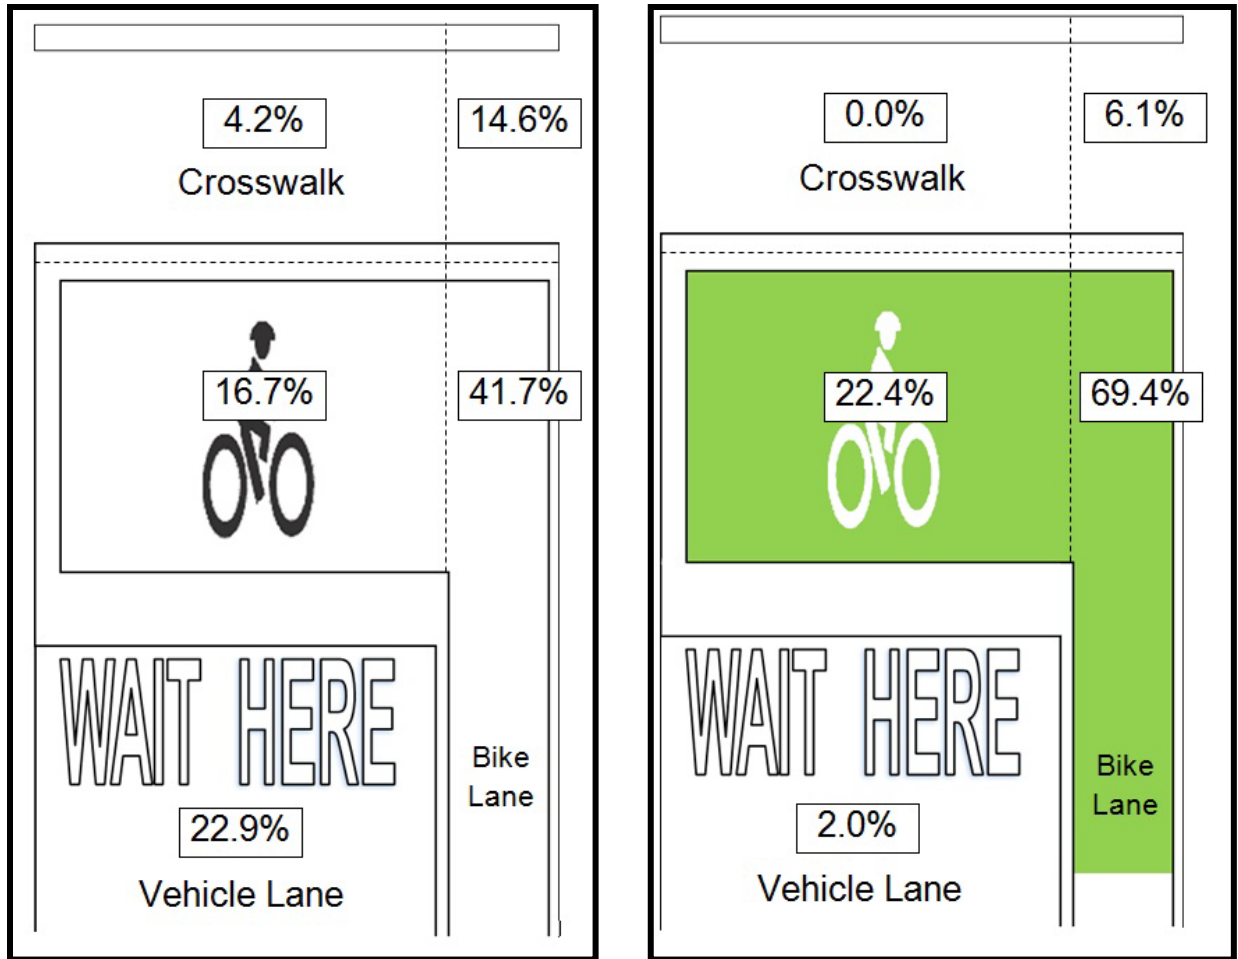
Figure 8 shows the percentage of bicyclists that stopped in each location at Shoal Creek Boulevard and Anderson Lane before and after color was added to the bicycle box. Only events when a bicyclist had the opportunity to access the bicycle box are shown. A bicyclist had the opportunity to access the bicycle box when a motorist did not encroach on the bicycle lane or stop line and there was no additional bicyclist blocking the bicycle box. This figure supports the assertion that the color in the bicycle box encourages bicyclists to stay within the bicycle box area. The percentage of bicyclists in this area increased while the percentage of bicyclists in the queue and beyond the stop line decreased. Ultimately, not taking into account the bicyclists who avoid or stop in the queue, the percentage of bicyclists who stopped behind the stop line increased from about 76% to 94%. This increase proved to be significant ($p = 0.012$).

Figure 8. Bicyclist stopping position by percentage on Shoal Creek Boulevard before and after color is added to the bicycle box

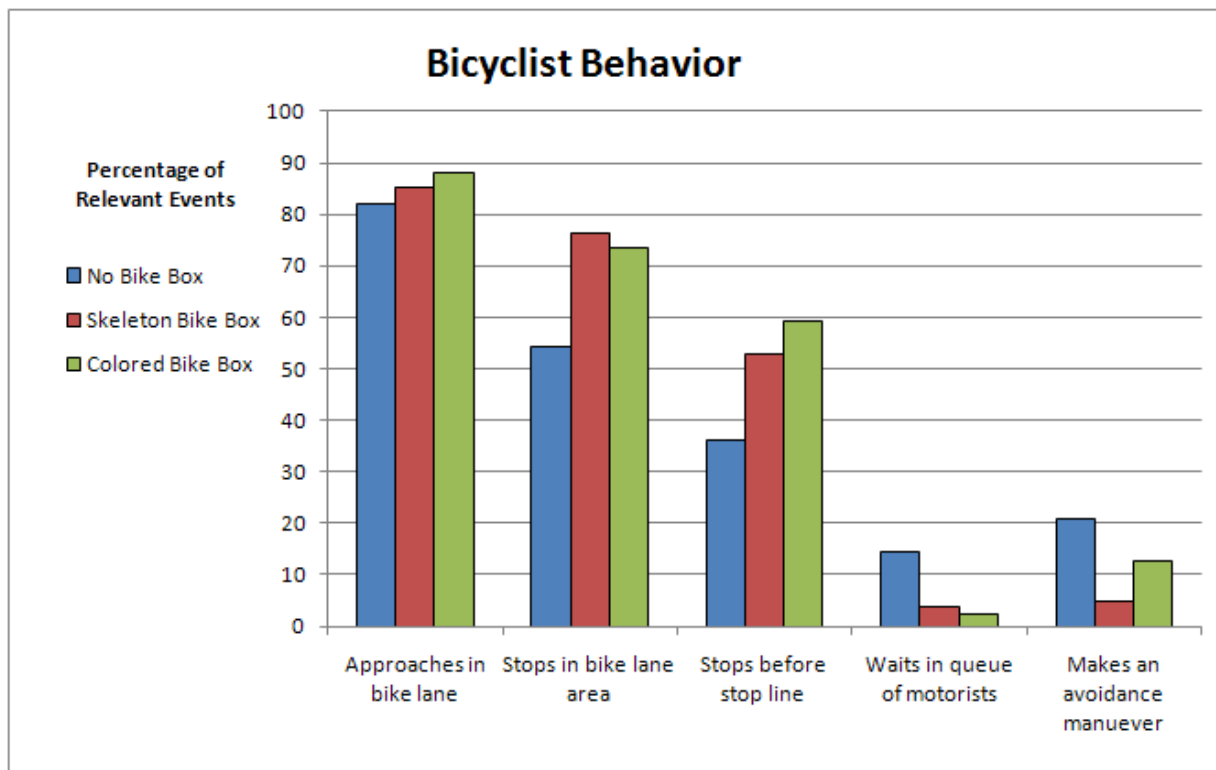
Figure 9 shows changes in bicyclist behavior before any bicycle box existed, after the skeleton bicycle box was installed, and after the chartreuse color was added. There was a steady increase in the number of bicyclists that use the bicycle lane on their approach to the intersection. This fact combined with the significant decrease in the percentage of bicyclists that waited in a queue of motorists ($p=0.007$) and the increase in the percentage of bicyclists that stopped before the stop line ($p=0.015$) after the skeleton bicycle box was installed suggests that bicyclists used the facilities at the intersection more appropriately. Also, a significant increase in the percentage of bicyclists that stopped in the bicycle lane area was observed. Since the bicycle lane continues on the other side of the intersection, bicyclists at this location might find it unnecessary to maneuver into the bicycle box area away from their straight line path. The main problem that resulted from bicyclists stopping in the bicycle lane area was that it hindered bicyclists who follow from entering the bicycle box. Often a queue of bicyclists would develop in the bicycle lane causing the bicyclists further back in the queue to be a greater risk or being right-hooked. Lastly, a significant decrease in the percentage of avoidance maneuvers ($p<0.001$) was observed when the skeleton bicycle box was installed, then this percentage

Figure 9. Bicyclist behavior on Speedway and 38th Street

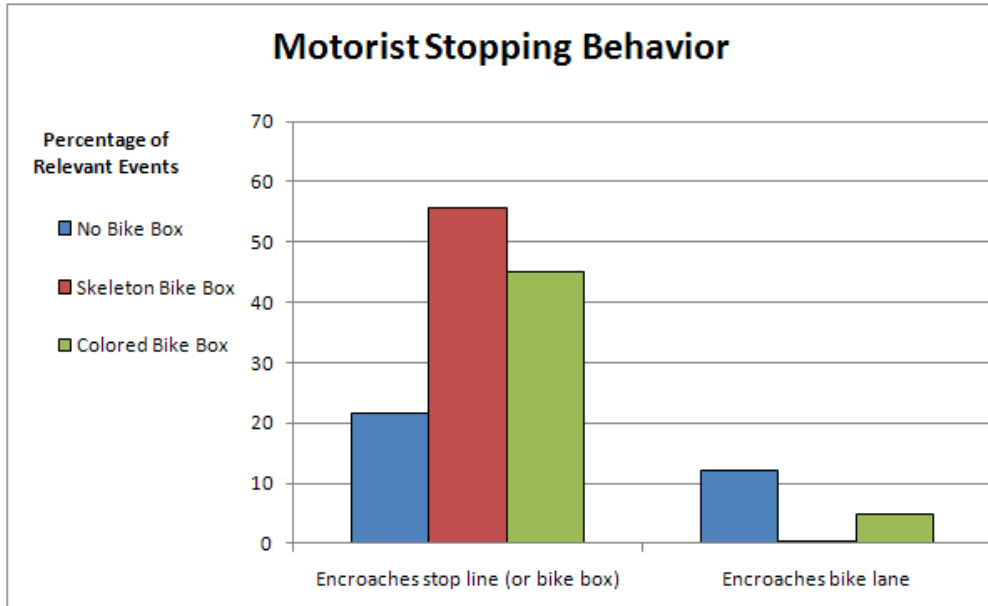
Additionally, motorist stopping position was recorded and is shown in Figure 11. Considerably more motorists encroach on their stop line after the skeleton bicycle box was installed, which could be due to motorists being unaware of the intention of the bicycle box. After the color was added, a significant change in the percentage of motorists stopped behind the bicycle box in the appropriate place was observed ($p=0.002$). Another positive result of the bicycle box was the decrease in the percentage of motorists that encroach on the bicycle lane after the installation of the skeleton bicycle box ($p=0.003$), which allows for bicyclists to safely bypass a queue of motorists and access the bicycle box. The small increase in motorists encroaching the bicycle lane after color was added could be partially attributed to some motorists exiting a driveway located just before the intersection. Lastly, the percentage of motorists making an illegal right turn on red was recorded. Contrary to Shoal Creek Boulevard, only 5.3% of motorists made an illegal right turn after the bicycle box was installed at this location. The low percentage of illegal right turns combined with the high volume of bicyclists makes this site well suited for a bicycle box. Also, the bicycle volume on this facility was much higher than on Shoal Creek Boulevard (20-60 bicyclists per hour as opposed to 0-30 bicyclists per hour), which likely contributes to the better motorist behavior since they know they are more likely to encounter a bicyclist.

Figure 11. Motorist stopping position when a bicyclist is present at Speedway and 38th Street

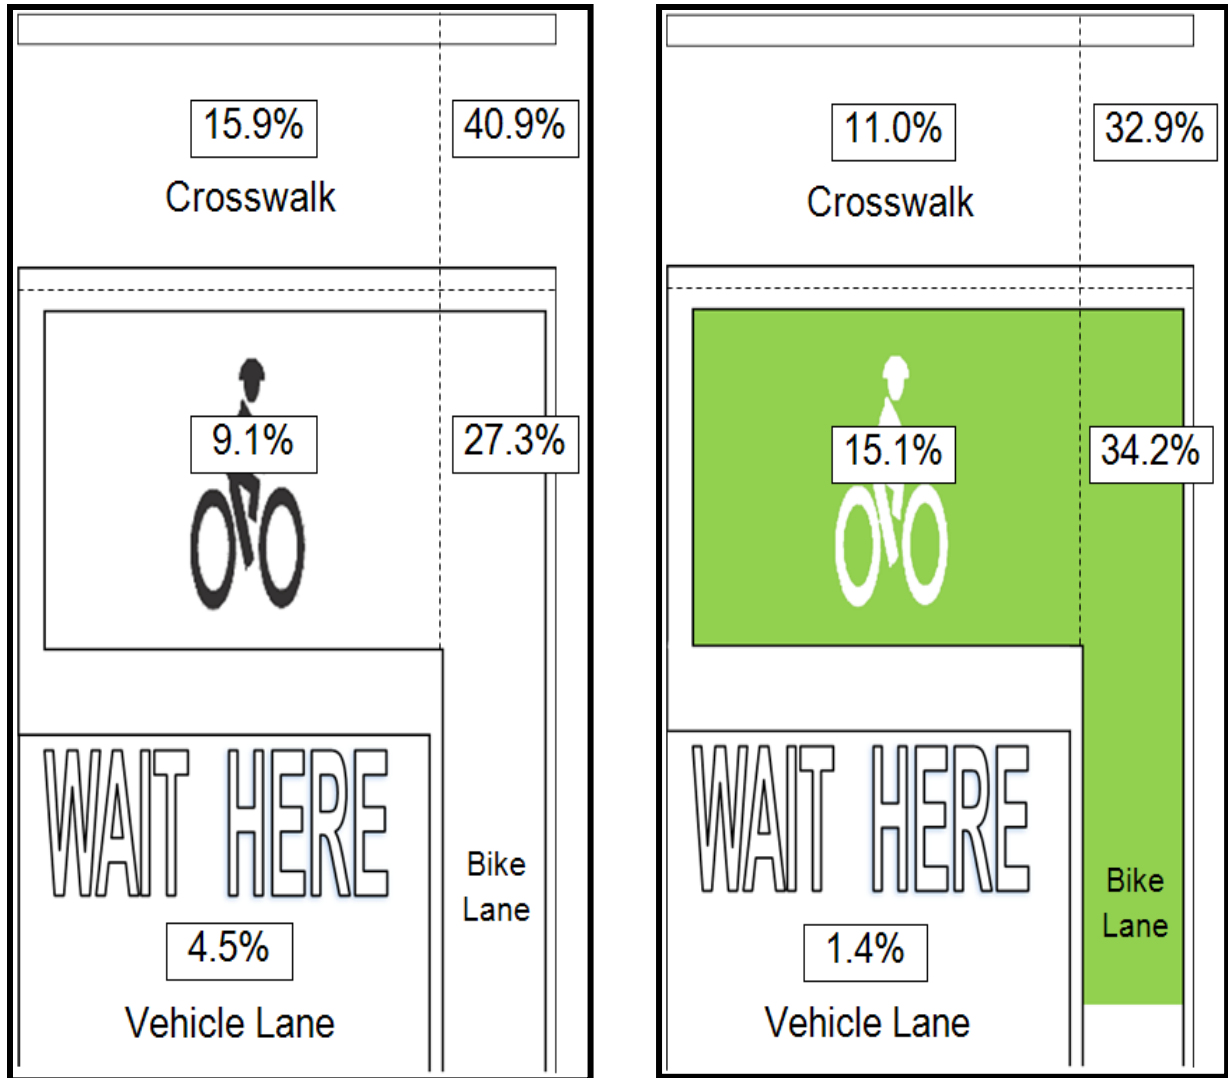
Figure 12 shows the percentage of bicyclists stopped in each location at Speedway and 38th Street before and after color was added to the bicycle box. Only events when a bicyclist was given the opportunity to access the bicycle box are shown. A bicyclist had the opportunity to access the bicycle box when a motorist did not encroach on the bicycle lane or stop line and there was no additional bicyclist blocking the bicycle box. After the chartreuse was added, bicyclists stayed within the colored area 13% more often, indicating a positive reaction to the color. A higher percentage of bicyclists began using the bicycle box correctly and did not encroach on the crosswalk. Additionally, a lower percentage of bicyclists waited in a queue of motorists, indicating that bicyclists are more confident using the bicycle lane to approach the front of the intersection and wait in front of motorists. Overall, 25% of bicyclists stopped in or in front of the bicycle box when only the skeleton was installed and 26.1% used the bicycle box after color was added. An ideal use of the bicycle box on southbound Speedway is shown below in Figure 13.

Figure 12. Bicyclist stopping position by percentage on Speedway before and after color is added to the bicycle box

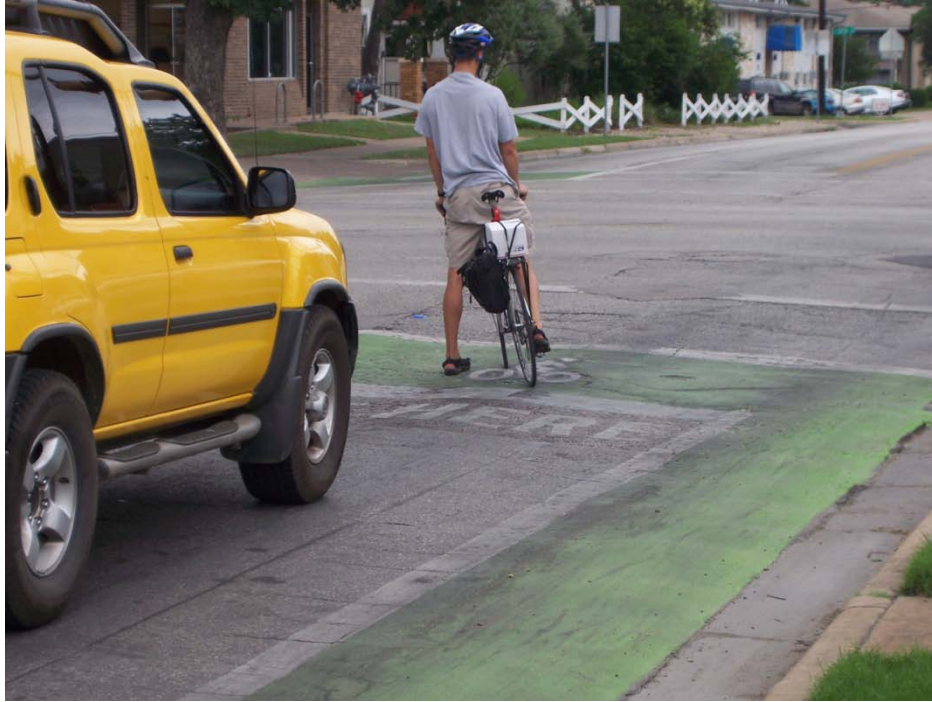
Figure 13. Bicyclist using bicycle box on southbound Speedway at 38th Street

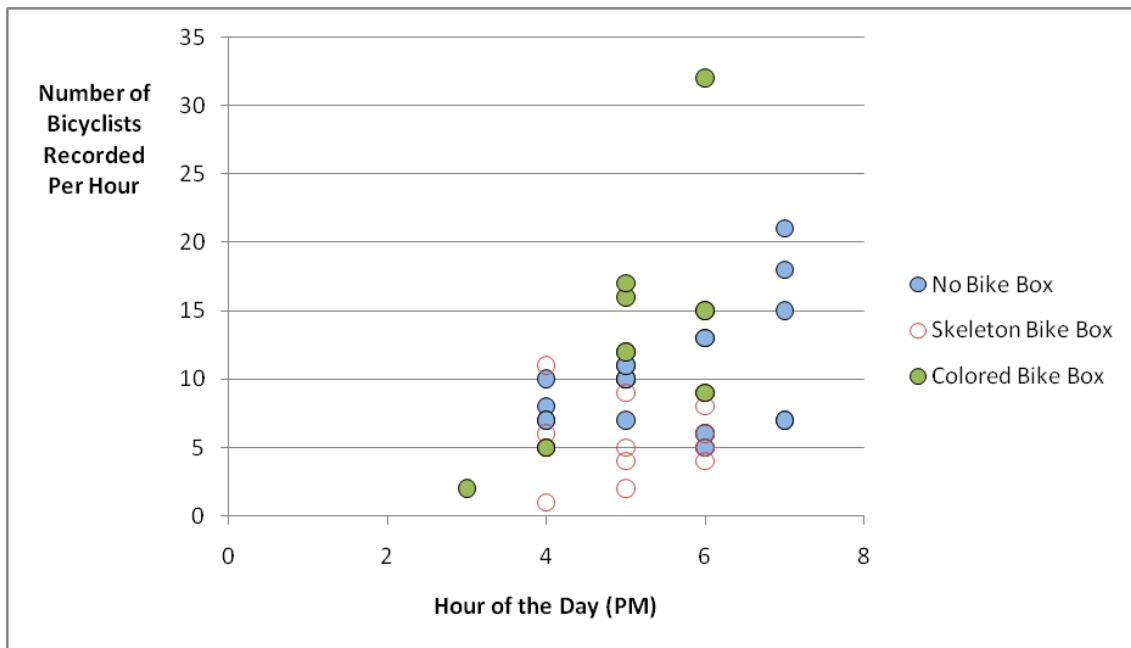
Figure 14 and Figure 15 show the total number of bicyclists observed by hour of the day at Shoal Creek Boulevard and Speedway, respectively. Shoal Creek Boulevard experienced an increasing number of bicyclists as the afternoon progressed for all three phases. Based on the high number of bicyclists between 5:00 PM and 7:00 PM, Shoal Creek Boulevard is most likely a commuter route with about 10 bicyclists an hour. Bicycle volumes on Speedway also increased as the afternoon progressed, but had a slightly more constant trend. This could be due to its proximity to The University of Texas since students tend to have more flexible schedules than typical commuters. On average, about 10 bicyclists per hour and 30 bicyclists per hour traveled along Shoal Creek Boulevard and along Speedway, respectively.

Figure 14. Number of bicyclists recorded each hour of the day on Shoal Creek Boulevard

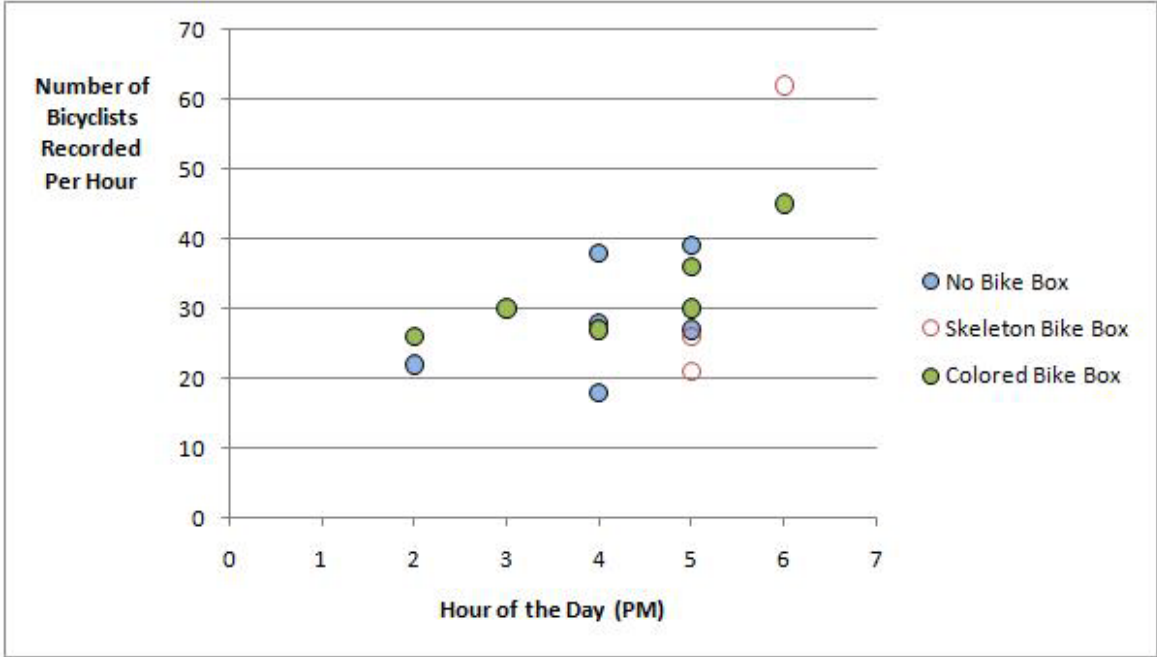
Figure 15. Number of bicyclists recorded each hour of the day on Speedway

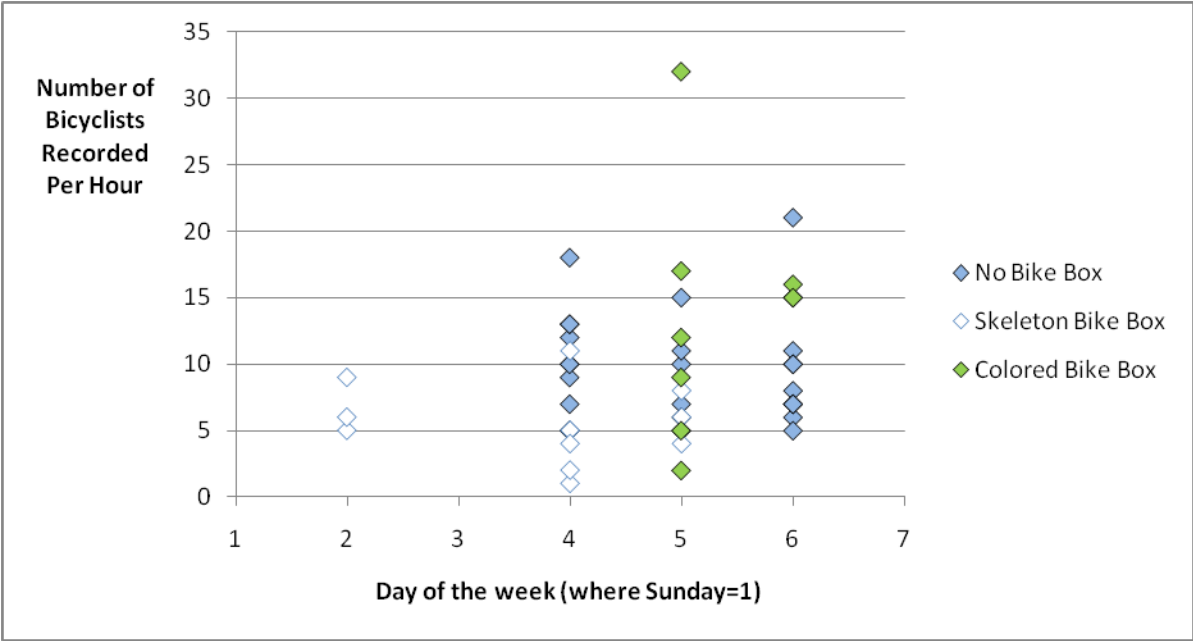
Figure 16 and Figure 17 show the total number of bicyclists observed each day of the week at Shoal Creek Boulevard and Speedway, respectively. Both sites show a varying number of bicyclists for each day of the week. Bicycle volumes on Shoal Creek Boulevard were observed to range from five to 10 bicyclists per hour, while they range from 20 to 40 bicyclists per hour on Speedway over the course of the week.

Figure 16. Number of bicyclists recorded each day of the week on Shoal Creek Boulevard

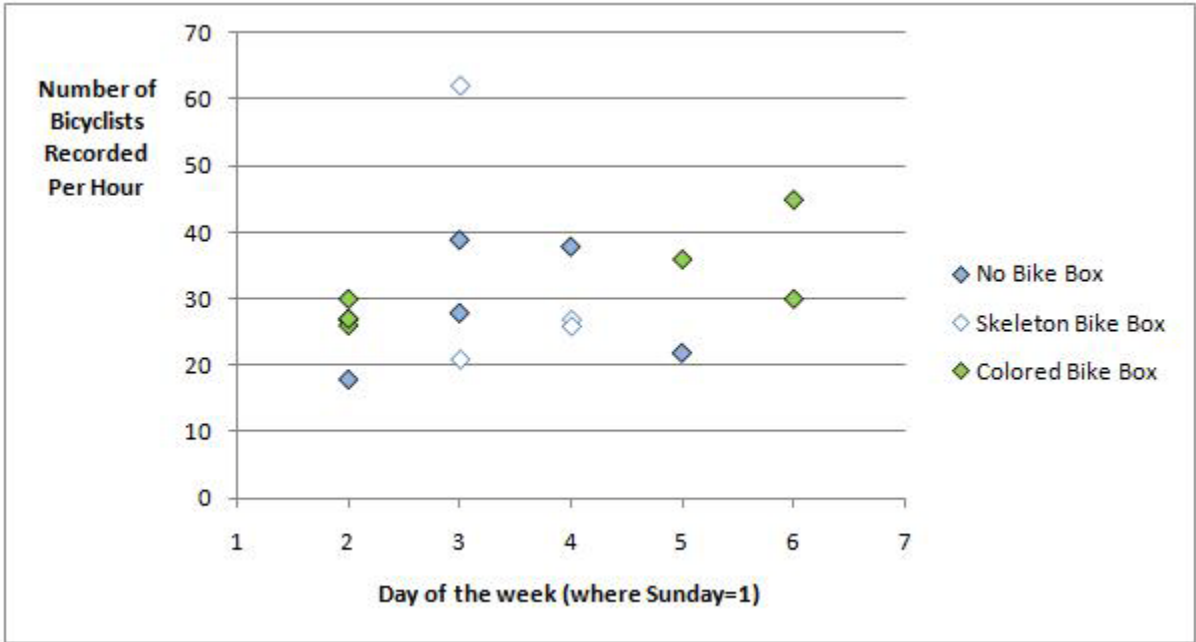
Figure 17. Number of bicyclists recorded each day of the week on Speedway

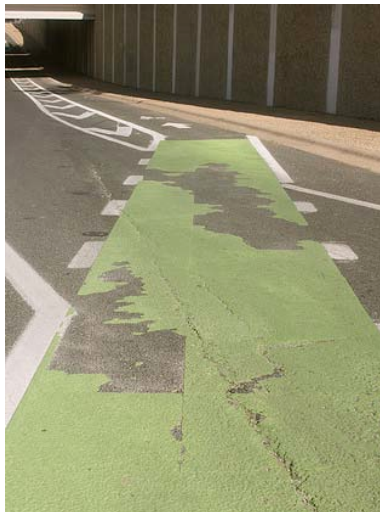
An installation error of the colored thermoplastic on Dean Keaton at the IH-35 exit ramp led to its quick deterioration. While waiting for the oil layer to dry, one of the crew members spilled a large amount of water onto the oil. This water eventually led to inadequate bonding between the pavement and the thermoplastic, which resulted in the thermoplastic breaking up (illustrated in Figure 18).

Also, the quality of pavement was a contributing factor to the quick deterioration of the colored thermoplastic, shown in Figure 18. In particular, the pavement on Speedway at 38th Street is cracked and uneven from the high volume of bus traffic. Clearing debris from the deep cracks of the application surface was nearly impossible; applying the oil-layer to these same cracks and the other surface flaws was also troublesome. The resultant colored thermoplastic was only tenuously bonded to the street surface at best.

Figure 18. Deteriorating thermoplastic on Dean Keaton Street at one of the I-35 exit ramps (breaking up in sheets)

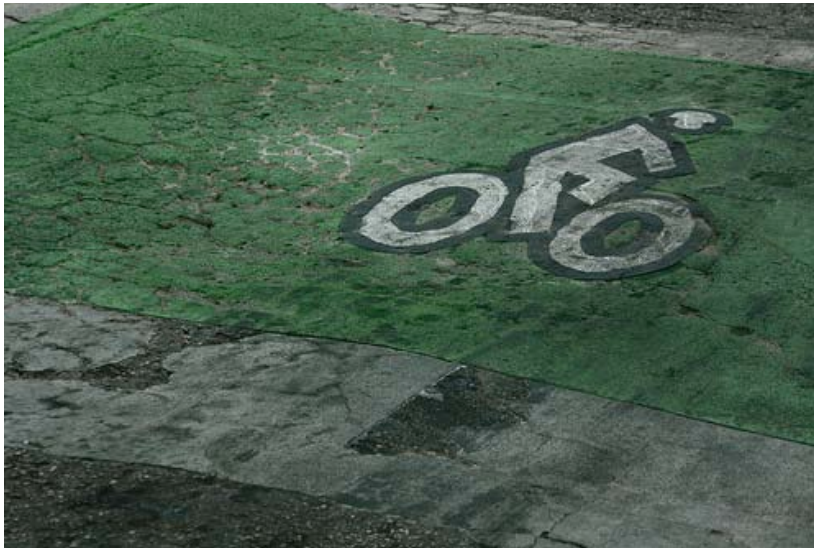
Additionally, the colored thermoplastic on Speedway was discolored very quickly (see Figure 19). This discoloration is likely due to the heavy bus traffic on Speedway, where there is a peak hourly volume of over 15 buses/hour. This discoloration may have been compounded by the buses, wider than personal cars, driving in the colored lane. Another concern with the thermoplastic is shown in Figure 20. It is unclear whether the uneven application of thermoplastic shown in the photograph is the result of a misapplication, the rough nature of the street surface, or a deterioration problem.

Figure 19. Poor quality of road led to the deterioration of the thermoplastic bike boxes on Speedway

Installing colored thermoplastic on new pavement would be the optimal situation. In the future, the City of Austin will most likely be applying a fresh asphalt surface (seal coat, microsurface, or overlay) before the installation of any proposed colored thermoplastic. A fresh street surface will provide a surface free of cracks and other defects, which could lead to erroneous installation and quick deterioration. These properties also lessen the importance of the oil layer in creating a bond between the pavement and thermoplastic.

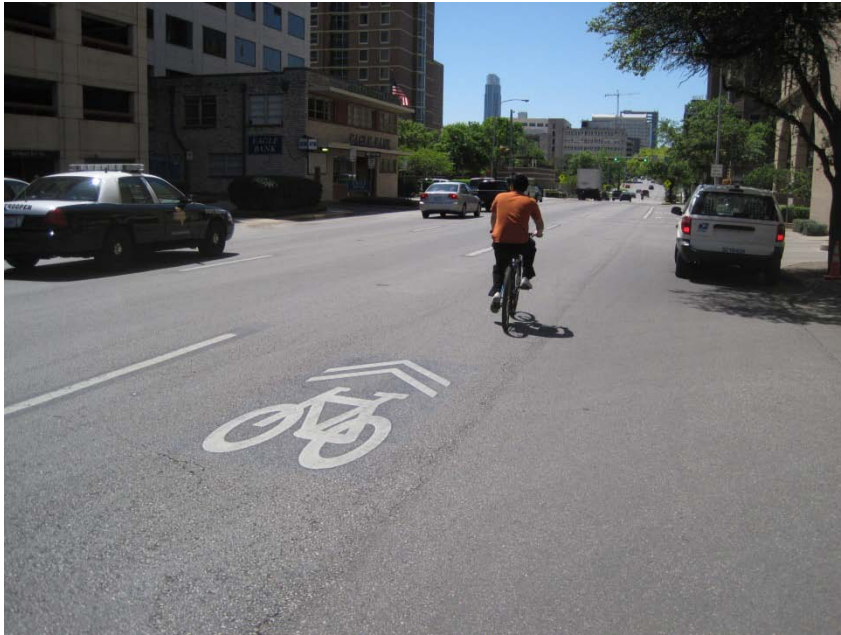
All sharrows were installed on top of a painted black box in order to provide visual contrast. Additionally, all sharrows were installed in the outside travel lanes. The sharrows on Guadalupe, Lavaca, and 51st Streets were installed in the center of the outside travel lanes as described by Figure 21. Each sharrow was individually placed in order to keep the sharrow out of the typical wheel paths and to avoid driveways where entering and exiting vehicles would have more variable wheel paths. By placing the sharrows outside of wheel paths the integrity of the thermoplastic was maintained.

Figure 21. Central placement of sharrow resulted in thriving thermoplastic five months after installation.

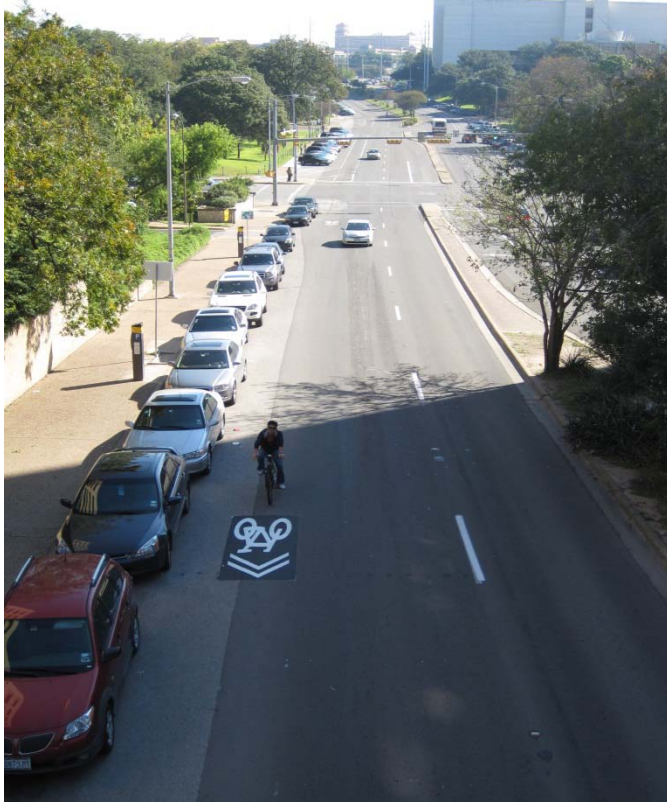
The west-bound sharrows on Dean Keeton differed from the other locations as these sharrows were aligned closer to the curb (see Figure 23). These sharrows were aligned closer to the curb for the following reasons: the outside travel lane on west-bound Dean Keeton was very large, there were no bus stops, the sharrows were only utilized to provide a bicycle facility to link two bicycle lanes, and west-bound bicyclists slow down to travel uphill.

Figure 23. Curb-justified placement of sharrows on west-bound, uphill Dean Keeton Street
