7. Portland - East Burnside at E. 97th

Existing Conditions

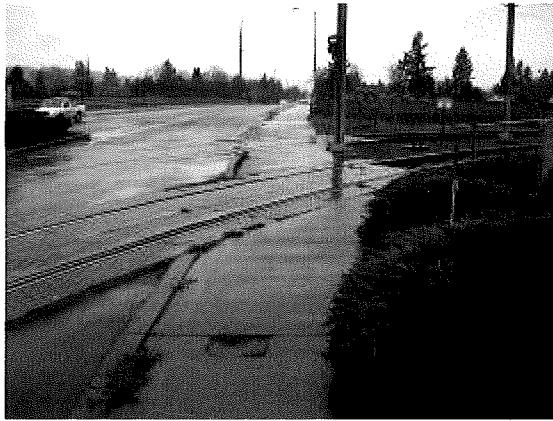
7-2: LRT tracks turning from East Burnside onto I-205 right-of-way.

- o The sidewalk on the north side of East Burnside requires better definition of the pedestrian channel on either side of and across the LRT tracks (Figure 7-2).
- o Visual and physical strengthening of the north/south pedestrian crossing over East Burnside is needed (Figure 7-3).

2. Explore methods to increase the sight distance to an oncoming LRV for pedestrians and bicyclists traveling westbound along East Burnside. Options for implementation may include: (a) convex mirrors could be installed on existing or new poles; or (b) seek the cooperation of ODOT to remove enough of the sound wall along I-205 multi-use path (+/- 50 linear feet) to enable maximum sight distance between the pedestrian walking west along East Burnside and an LRV turning from the I-205 ROW onto eastbound East Burnside. As necessary, and in conjunction with this portion of sound wall removal, consider acquiring the property closest to East Burnside. Convert this property to a passive green space. (An important consideration here is that the property closest to East Burnside cannot be negatively impacted by freeway noise.)

3. Enhance conditions that warn pedestrians and cyclists of an oncoming LRV by considering the addition of active warning devices and channeling devices to the East Burnside westbound sidewalk crossing. These can include a flashing "train" signal, pedestrian gates, railings, or bollards and cable, and creative use of landscaping.

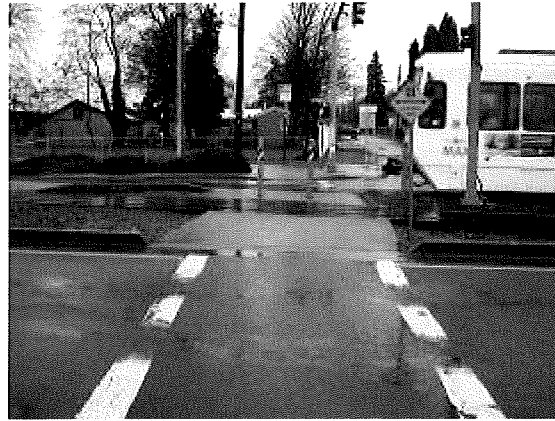
7-3: East Burnside pedestrian crossing appears old and worn.

1. Clarify design of existing East Burnside pedestrian crossing. Consider changing surface material to concrete, removing existing bollards and replacing, relocating or adding new bollards positioned more effectively to guide the pedestrian through the crosswalk.
