Oregon Department of Transportation
**POWELL BOULEVARD
ROAD SAFETY AUDIT**

20th Avenue to 33rd Avenue
September 2014

Powell Boulevard Road Safety Audit (RSA)

20th Avenue to 33rd Avenue
Mile Point (M.P.) 1.76 to 2.49

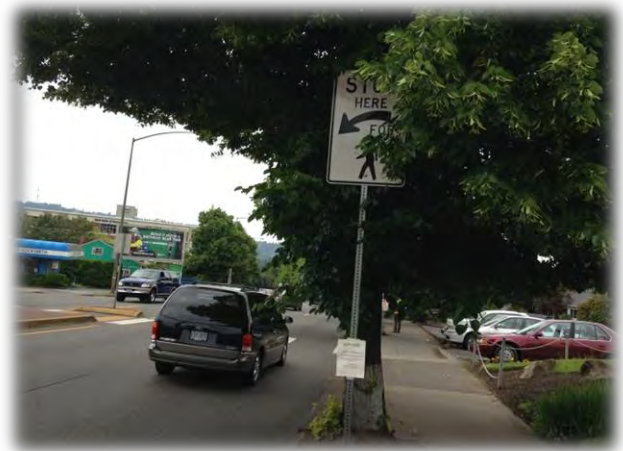
- Location of pedestrian crossings
 - Several pedestrian crossings were located downstream from transit stops, as shown in Exhibit 4. This placement results in a stopped bus at the transit stop sometimes blocking a driver’s view of a crossing pedestrian.
- Sign visibility
 - The visibility and reflectivity of signs, including pedestrian crossing signs, was restricted by street trees, as shown in Exhibit 5 and Exhibit 6. The tree canopies extend below the signs further restricting visibility of the signs. The limited visibility of signs may contribute to subsequent approaching drivers failing to see regulatory and/or warning signs and yield to the pedestrian.

Exhibit 5 Signs Blocked by Trees

- Trim trees to provide clear height to make visible signs to drivers. This includes trimming the tree canopy as well as undergrowth at the base of the tree. Consider a minimum tree trimming height of 12 feet (typical height of sign assembly) to allow for visibility of all signs.
- Provide signing and striping improvements, which may include signs in Exhibit 12, to increase awareness of pedestrian crossings.
- Provide a leading pedestrian phase at signalized intersections to allow pedestrians to enter the intersection (increasing their visibility) before vehicles enter the intersection.
- Expand pedestrian landing areas on the corners of Powell Boulevard/26th Avenue to discourage pedestrians (e.g., students at Cleveland High School) from standing in the roadway.

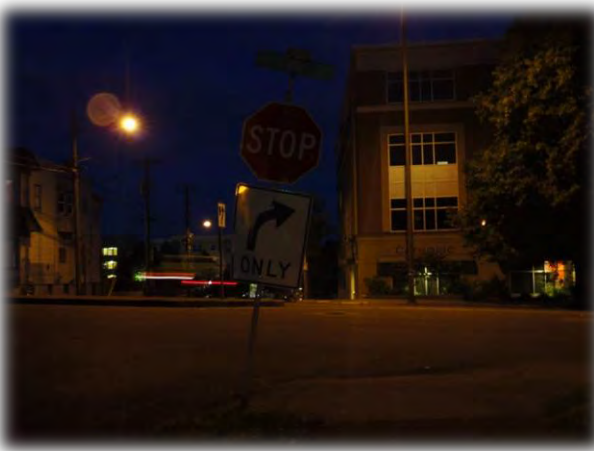
Exhibit 6 Signs with Limited Reflectivity

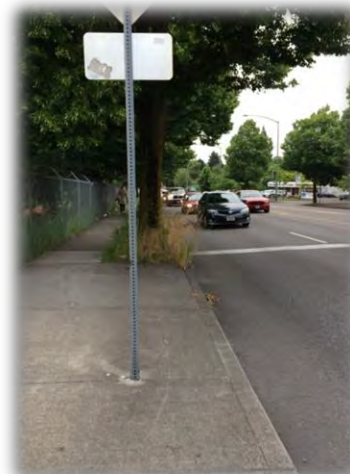
Exhibit 7 Restricted Sight Distance for Pedestrians

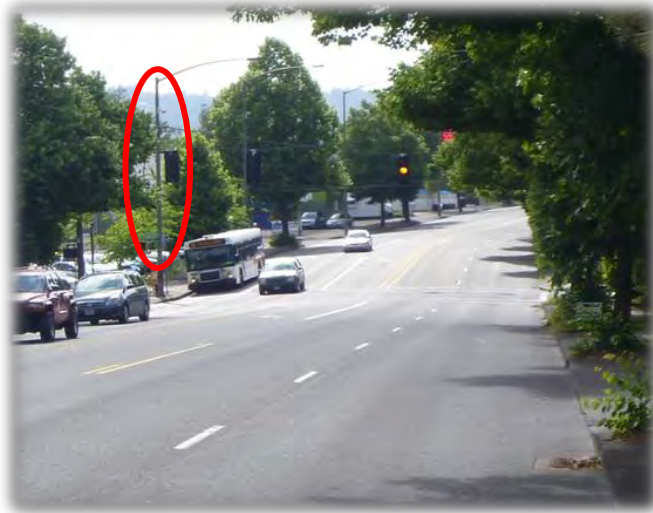
Exhibit 15 Potential Location for Supplemental Signal Head at Powell Boulevard/26th Avenue

- Complete tree trimming to increase visibility of signs and approaching signals.
- Consider supplemental signal heads at near left side corner, as illustrated in Exhibit 15.
- Review sign placement and visibility. For example, consider using the back side of cantilever for the “Next Signal” sign for the eastbound approach to 26th Avenue as illustrated in Exhibit 16.

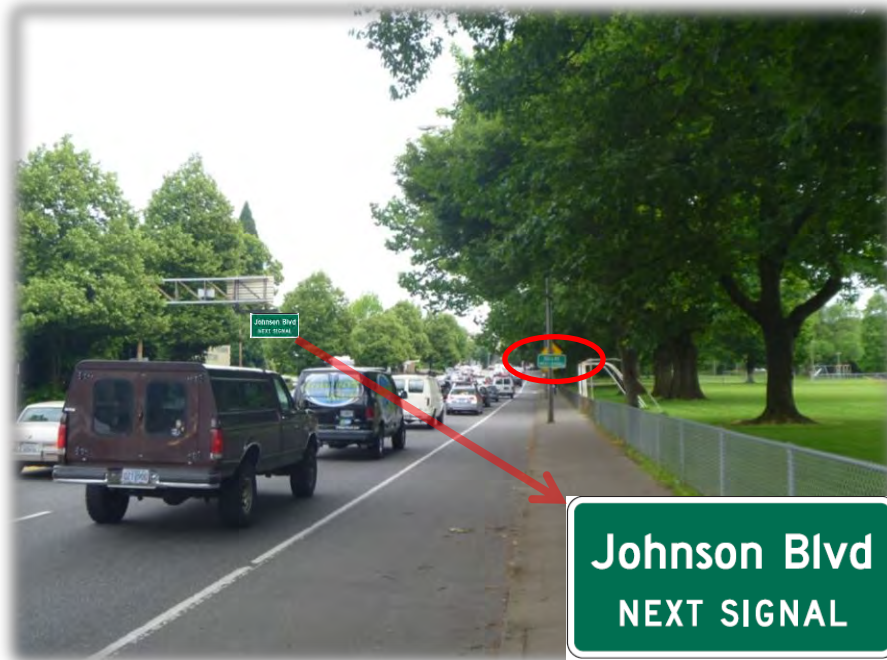
Exhibit 16 Example of Using Cantilever for Next Signal Sign at Eastbound Approach to 26th Avenue

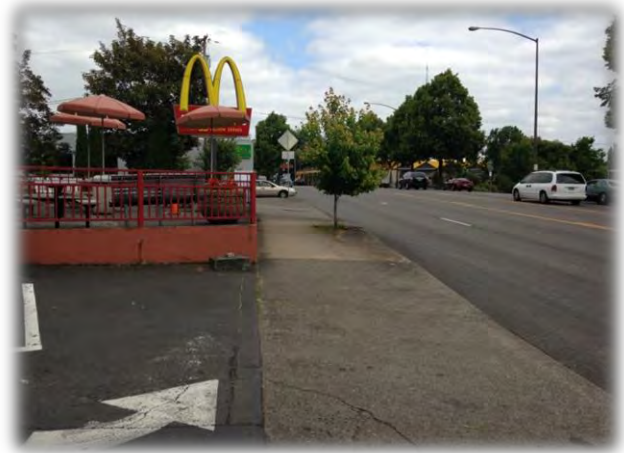
The study corridor is surrounded by a mixture of land uses including a high school, residential areas, fast food restaurants, a brewery, hotel, and a bowling alley. There are many access points for these businesses along the corridor. Some parcels have multiple access points onto Powell Boulevard. Some of these access points overlap with pedestrian crossing medians, as illustrated in Exhibit 19. There is a two-way, left-turn lane located throughout the length of the study area. The RSA team observed difficulty for drivers making left-turns from driveways and side streets due to limited sight distance (due to horizontal curves, vertical curves, and buildings), as shown in Exhibit 20, as well as the approaching grades on side streets.

Exhibit 20 Example of Limited Sight Distance from Access Point

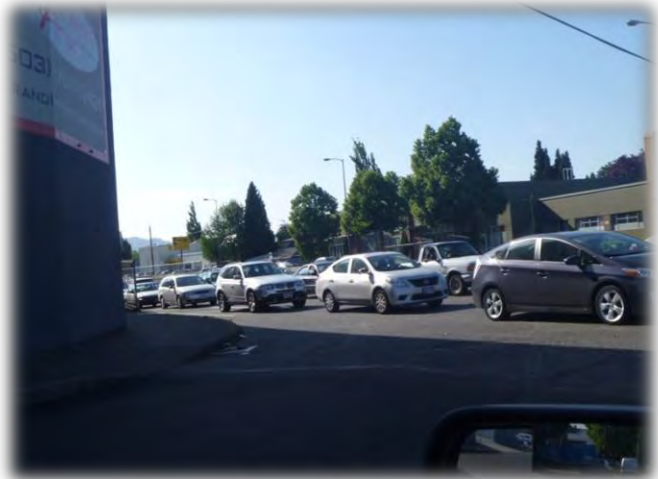
The Powell Boulevard/20th Avenue intersection has a center median separating the eastbound and westbound traffic. Side streets are restricted to right-in, right-out movements, as illustrated in Exhibit 25. The northbound approach has limited sight distance to the west, as shown in Exhibit 26. The northbound and southbound approaches lack one-way signing and right-turn only pavement markings to inform drivers of the allowed movements, as illustrated in Exhibit 27 and Exhibit 28.

Exhibit 26 Illustration of Limited Sight Distance (Northbound Approach) to the West

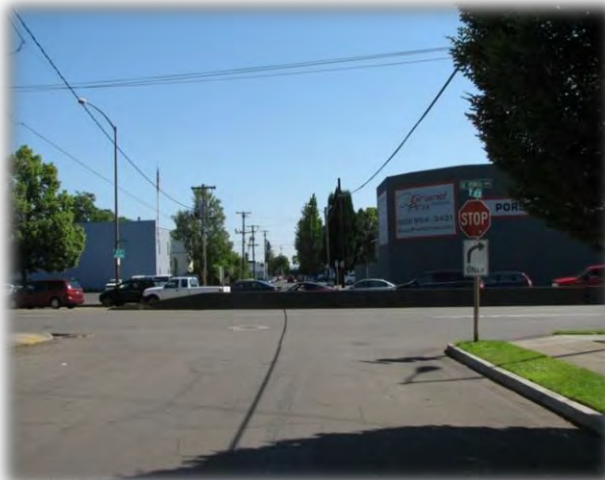
Exhibit 27 Lack of Right Turn Only Pavement Marking

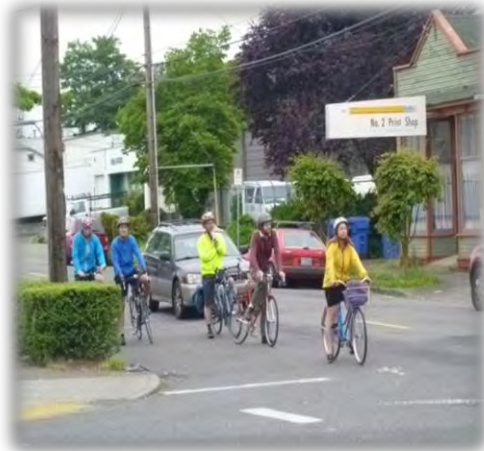
21st Avenue has single lane approaches and lacks bicycle lanes, as shown in Exhibit 29. Dented signal poles, as shown in Exhibit 30, reveal vehicles that are likely trucks that have struck the poles while making turning maneuvers.

Exhibit 29 Bicyclists Sharing the Lane with Vehicles on 21st Avenue at Powell Boulevard

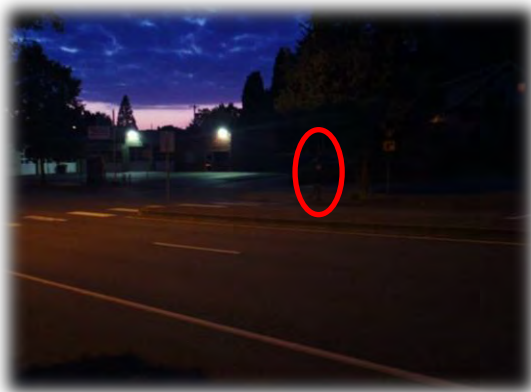
The Powell Boulevard/24th Avenue intersection is a three-leg, unsignalized intersection. It has a marked crosswalk on the east side of the intersection connecting to the park on the south side of Powell Boulevard. The crosswalk was difficult to see at night due to the placement of lighting; as shown in Exhibit 34. An eastbound bus stop located prior to the crosswalk restricts the line of sight between pedestrians and drivers when occupied by a bus. The majority of crashes at this intersection are rear-end crashes. Two of the crashes were pedestrian crashes. During the RSA field work, the intersection was blocked by queues from nearby signals during both the AM and PM peak hours, as shown in Exhibit 35.

Exhibit 34 Pedestrian Crossing is Dark at Night

- Consider adding an RRFB and pedestrian scale lighting in advance of the crosswalk, as shown in Exhibit 36.
- Consider removing select tree(s) to increase visibility of crossing, signage, and pedestrians. Consider eliminating or relocating eastbound TriMet stop downstream of the crosswalk. The spacing between this stop and the next stop at 26th Avenue should be considered in the decision.

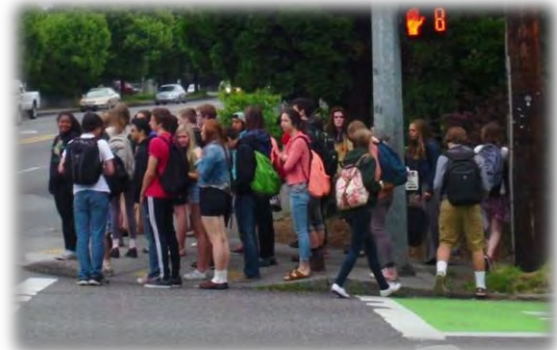
The intersection is a transfer point between the east-west TriMet routes along Powell Boulevard and the north-south routes along 26th Avenue. The RSA team observed buses unloading a group of students who crossed the intersection as a group and were unable to fit on the sidewalks on the corner, as shown in Exhibit 38. Students were observed standing in the street. In addition, there is a

Exhibit 38 Pedestrians Wait in the Street

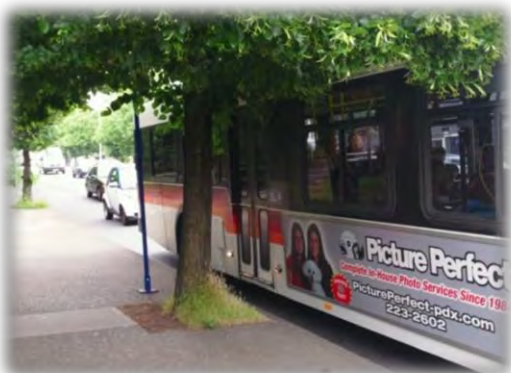
Exhibit 39 Conflict between Bus Drop Off and Tree

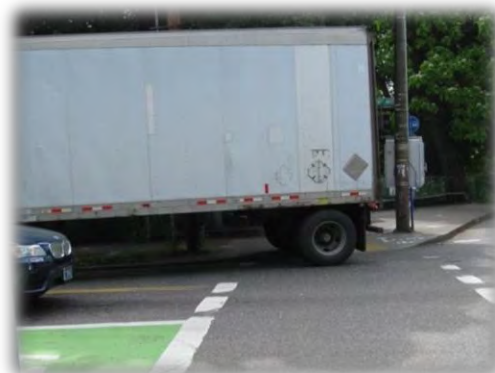
Some of the intersection conflicts may be associated with the signal timing and signal cycle lengths. The RSA team observed cycle lengths of approximately 60 seconds during the afternoon peak hours that appear undesirable compared to similar corridors within the metropolitan area. In addition, the team observed vehicles running the red lights at the end of left-turn phases on the east-west mainline movements, likely due to impatience associated with the long queues. Powell has protected left-turning movements, but the side streets have permitted left-turn movements. Trucks were observed having difficulty making right-turns at the northeast and southwest corners of the intersection without encroaching on the curb and sidewalk, as shown in Exhibit 40. When the curb is filled with students from the TriMet buses, the trucks' inability to make the turning movement without encroaching on the curb presents conflicts between pedestrians and trucks.

Exhibit 40 Tight Turn Radius

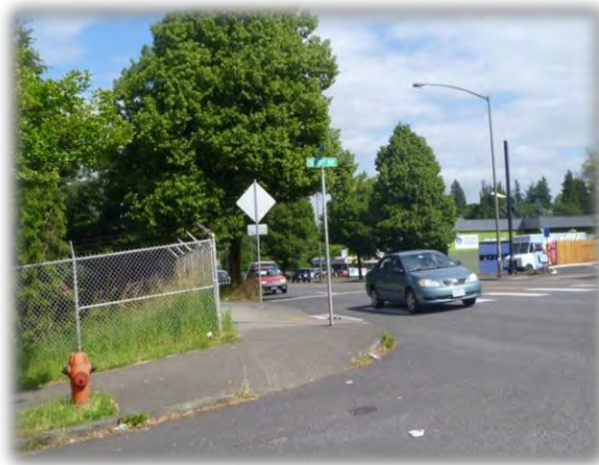
The southbound intersection approach has restricted sight distance to the east due to a lack of maintenance of vegetation on the school property corner and the approach grade, as shown in Exhibit 44. The northbound approach (Motel 6 driveway) has restricted sight distance caused by a fence in the southwest corner of the intersection, as shown in Exhibit 45.

Exhibit 44 Restricted Sight Distance to the East from Southbound Approach

- Consider removing vegetation in northeast corner of the intersection to improve sight distance.
- Consider making the southbound approach right-only (due to new pedestrian refuge median as well as restricted sight distance).

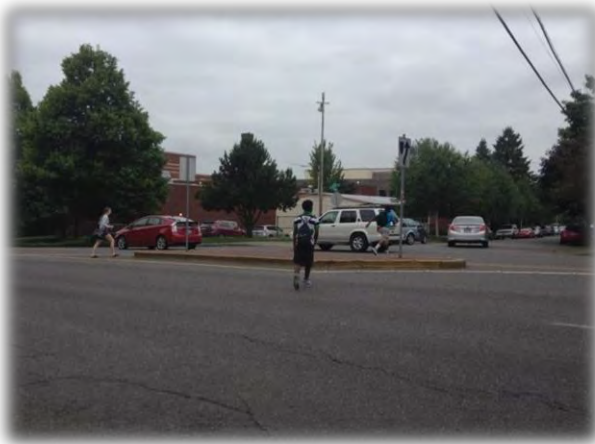
Exhibit 50 Students Crossing Powell Boulevard

Students were observed walking from the south up 28th Avenue to reach the high school and crossing at the 28th Avenue/Powell Boulevard intersection, despite the lack of a marked crossing (this is a legal crossing), as shown in Exhibit 50 and Exhibit 51. Although the lack of a marked crossing does not make the crossing illegal, crossings at 28th Avenue are more challenging than crossing at the marked crossings at 28th Place or 26th Avenue. Parents were also observed dropping their students off on 28th Avenue, south of Powell Boulevard. The majority of these students then crossed Powell Boulevard at 28th Avenue. Other people were observed crossing at the intersection to catch westbound TriMet buses. These pedestrians exhibited risky behaviors because they were often trying to cross Powell Boulevard quickly by stepping into the roadway to get vehicles to yield to reach the transit stop before the bus arrived.

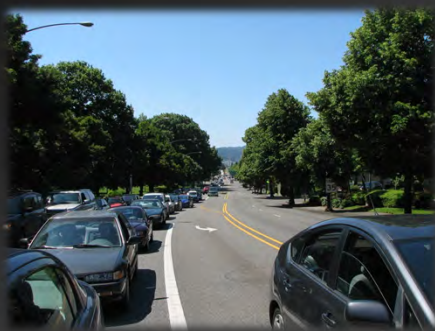
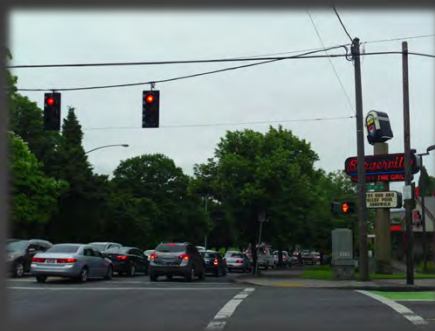
System-Wide Issue: Signal Queuing

- Rear-end crashes associated with queues
 - Queues extend to/through next signal

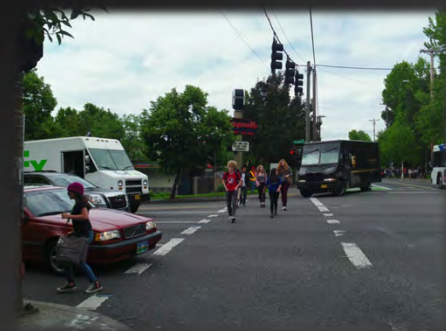
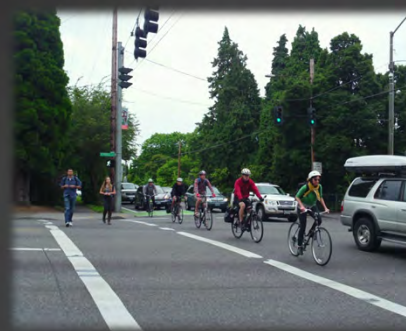
System-Wide Issue: Signal Conflicts

- Permissive left-turn phasing

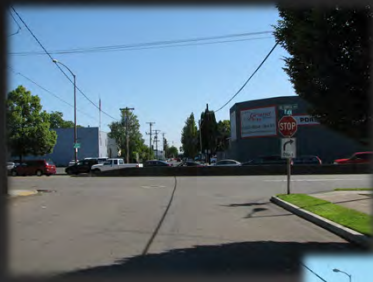
Lack of Right Turn Only Pavement Marking

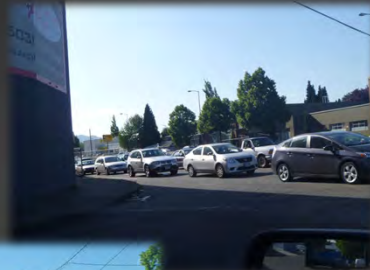
Limited Sight Distance (Northbound) & Eastbound Bikes

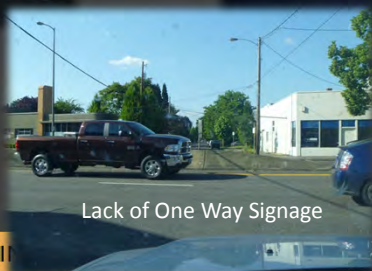
Lack of One Way Signage

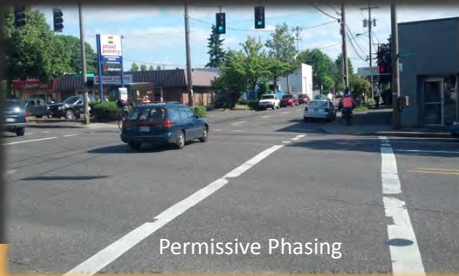
- Single-lane north- and southbound approaches
- Crash data:
 - Turning movement

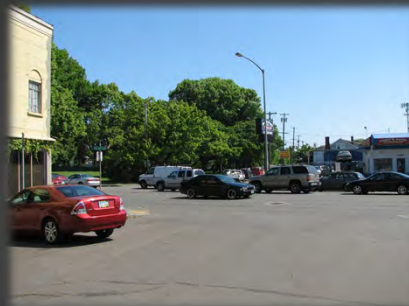
Powell Blvd & 22nd Ave

- Angle parking on east side is used incorrectly
- Northbound stop bar is set back too far
- Offset intersections
- **Suggestions:**
 - Curb extension on SE corner
 - Move stop bar up to improve sight distance

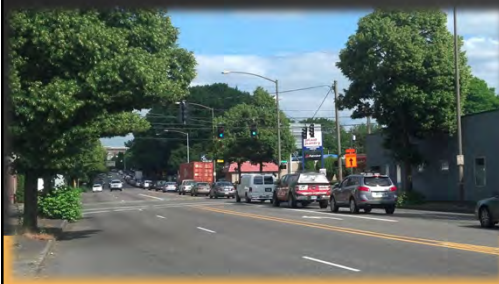
- Intersection & crossing blocked by queues during AM & PM peak hours
- Bus stop located before crossing (eastbound)
 - Transit Ons/Offs are relatively low

Queue blocking crosswalk during PM peak

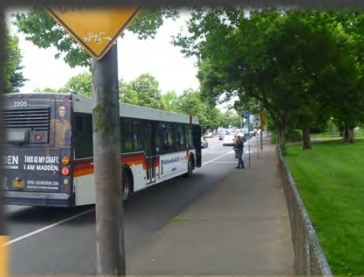
Eastbound transit stop located prior to crosswalk

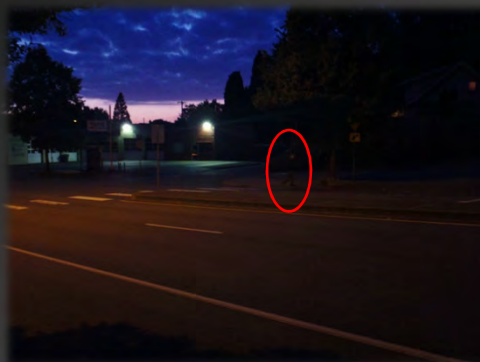
- Difficult to see crossing at night
 - Luminaire located behind crosswalk

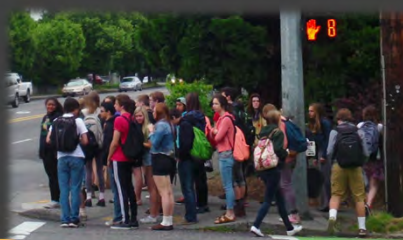
- Large number of pedestrians do not fit on corners
- Right-turns are tight at the NE and SW corners
- Heavy north/south bike traffic
- Limited cross-section width
 - 3' bike lanes at intersection
- Driveway located on SE corner

Pedestrians waiting in street

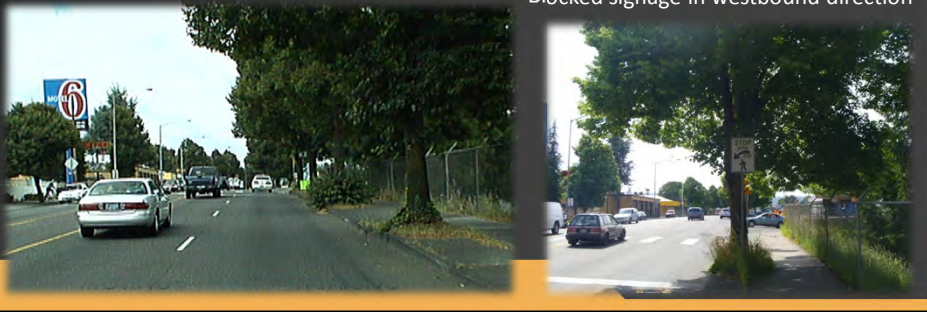
The crosswalk was observed to be difficult to see when approaching in the westbound direction because trees blocked the crosswalk signs. The team noted the crosswalk was particularly difficult to see during nighttime conditions. The transit stops are also located prior to the crosswalks. The recorded boardings at these transit stops were relatively low compared to others in the corridor. In addition, there is a food cart next to the motel that may have led to some pedestrian demand at this crossing.

- Crosswalk difficult to see
 - Trees restrict sight distance westbound
- Crash history shows high number of crashes and pedestrian-involved crashes

Blocked signage in westbound direction

- Improve pedestrian crossing to include
 - Pedestrian refuge island
 - RRFB
 - Lighting

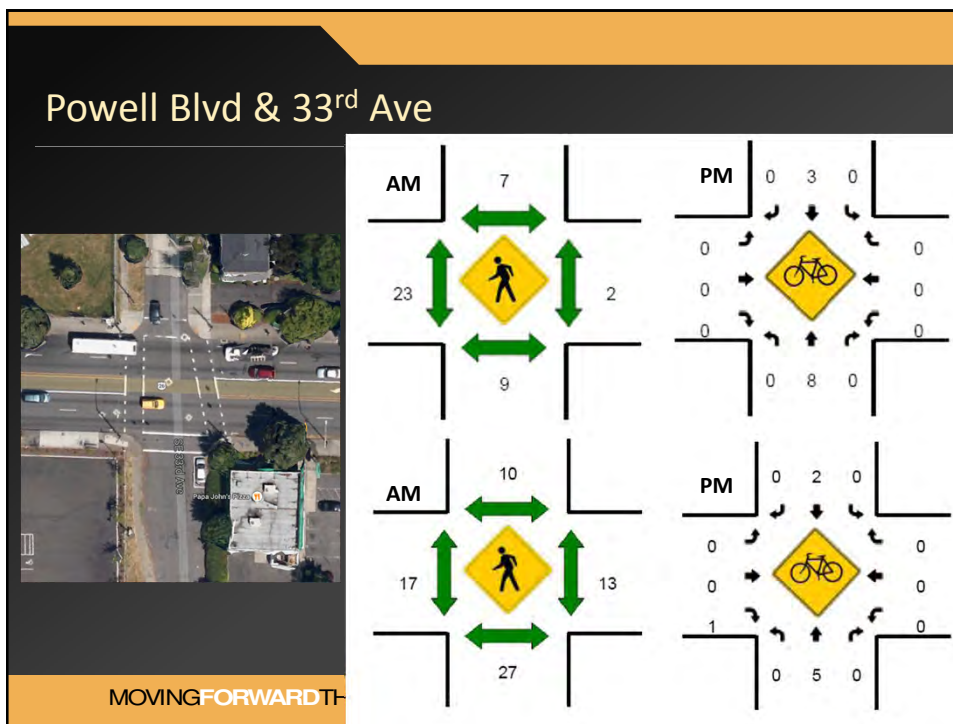
Issues: Powell Blvd & 33rd Ave

- Low mounting of signal heads
- Difficult to turn left off of Powell
- Long signal cycle
 - Pedestrians and bicyclists became impatient
 - Bicyclists used pedestrian push button, even though striping indicated bicycle detection

- Sidewalk section missing on east side of south leg at intersection
- Shrubs on northeast corner block drivers' vision
- Dented poles
- Zip cars parked on south leg of intersection, at intersection

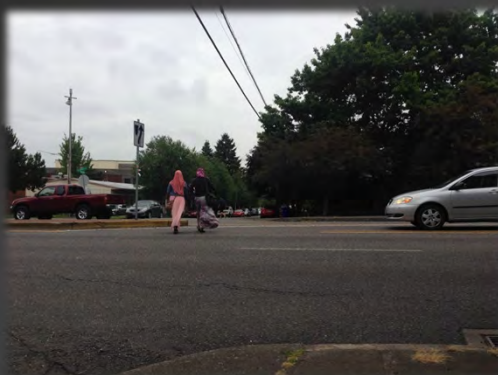
- Queues in left-turn pockets block sight distance because of curve

Students crossing while vehicle turns left

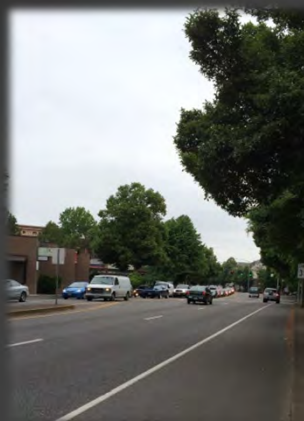
Issues: Powell Blvd & 28th Ave

- Queues from signal often back up past this location
- Westbound bus stop is located in front of median (which is used as a crossing)
- Large residential land use to the south
- Westbound left-turns into parking lot by daycare

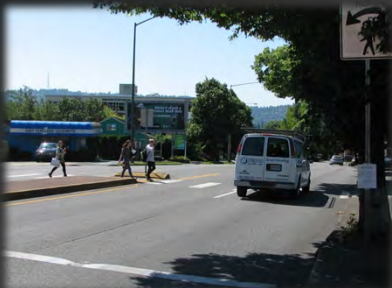
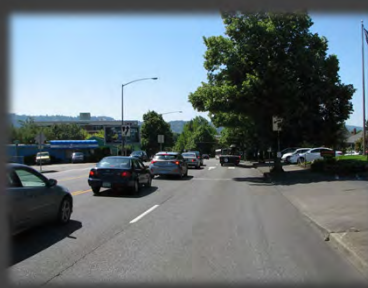
Issues: Powell Blvd & 28th Pl

- Traffic from bus stops block crosswalk
- Queues from 26th Ave signal sometimes block crosswalk

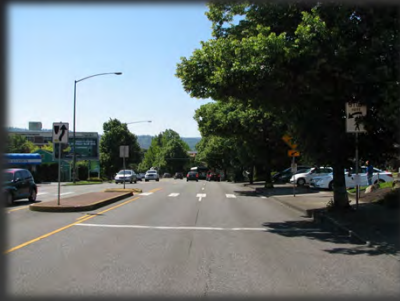
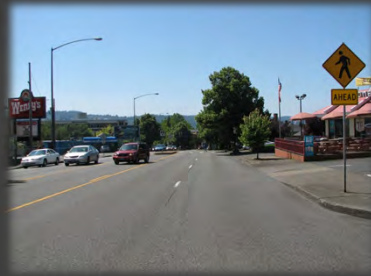
Issues: Powell Blvd & 28th Pl

- Limited visibility of signs and lighting
- Vehicles making westbound left-turns onto side street just past pedestrian median

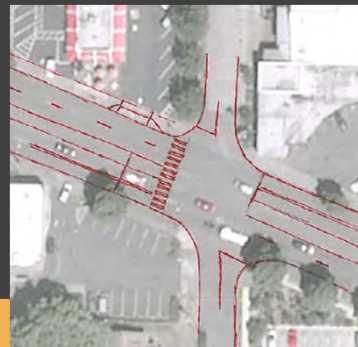
Powell Blvd & 29th Ave

- Issues:
 - Both sides of Powell have many driveways
 - Interaction between commercial land uses
 - Crash data does not show strong trends at driveways
 - If land use changes, reevaluation may be needed
